Florida Department of
TRANSPORTATION

**Tampa Bay Bridge Crossings
Resiliency Overview
November 6th, 2023**

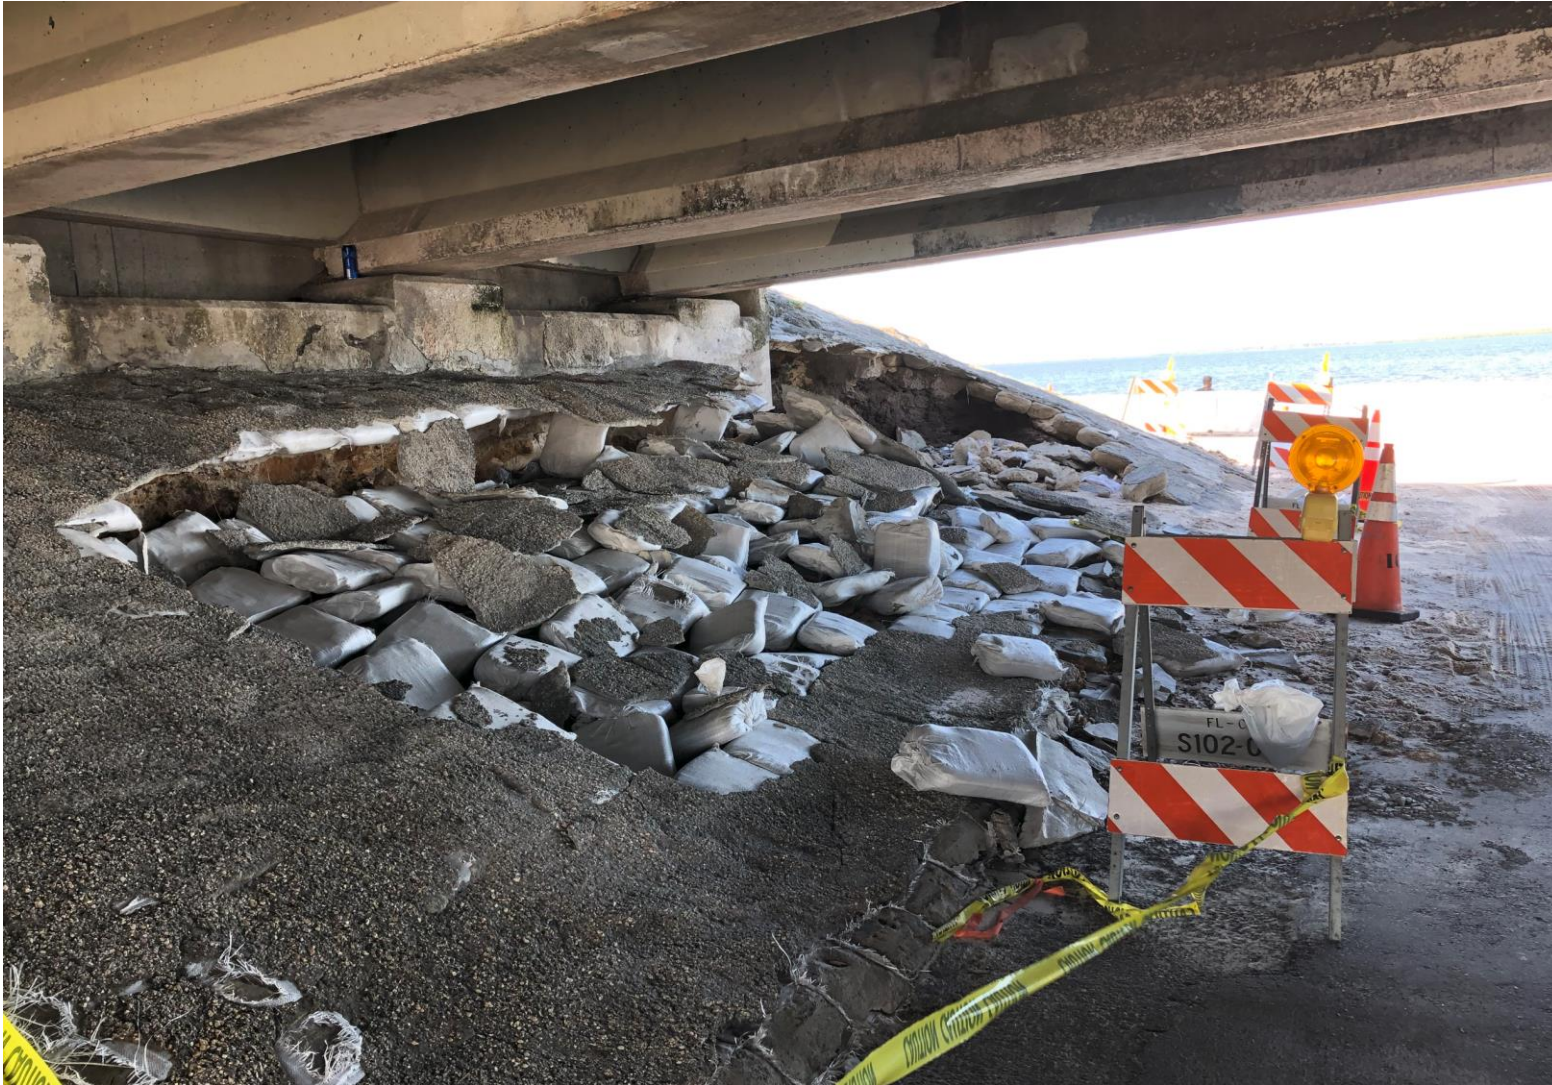
Courtney Campbell Main Bridge

Tropical Storm Eta (2020)

Slope damage at west end

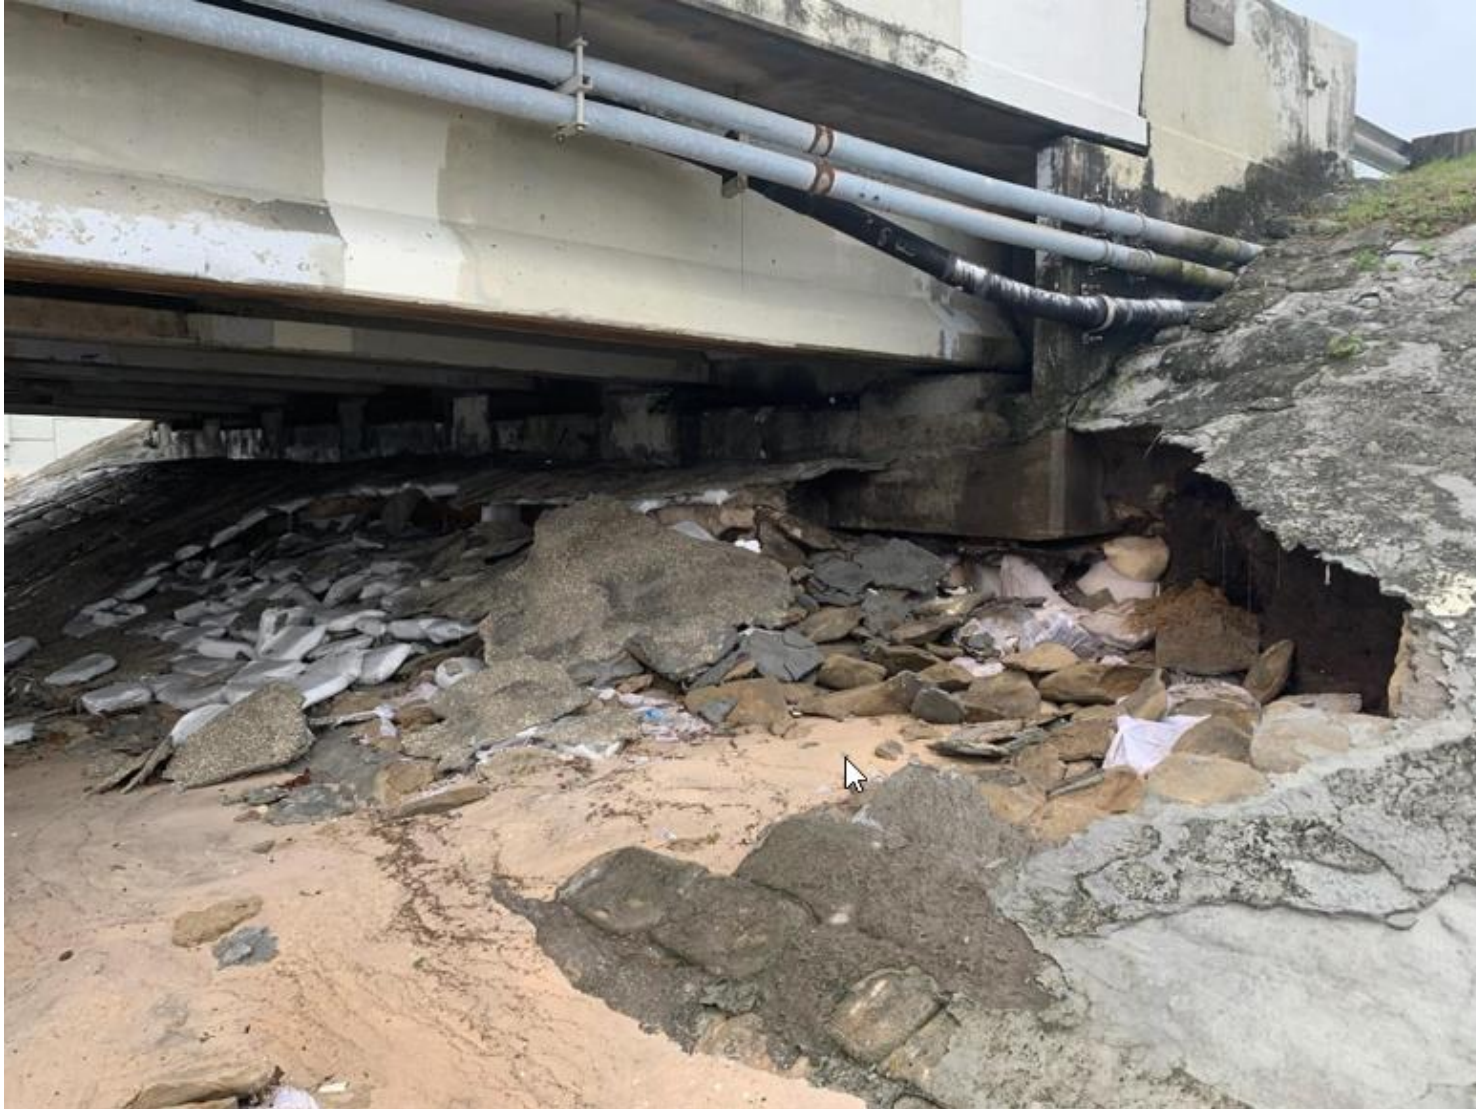
Courtney Campbell Main Bridge

Tropical Storm Eta (2020)

Slope damage at west end

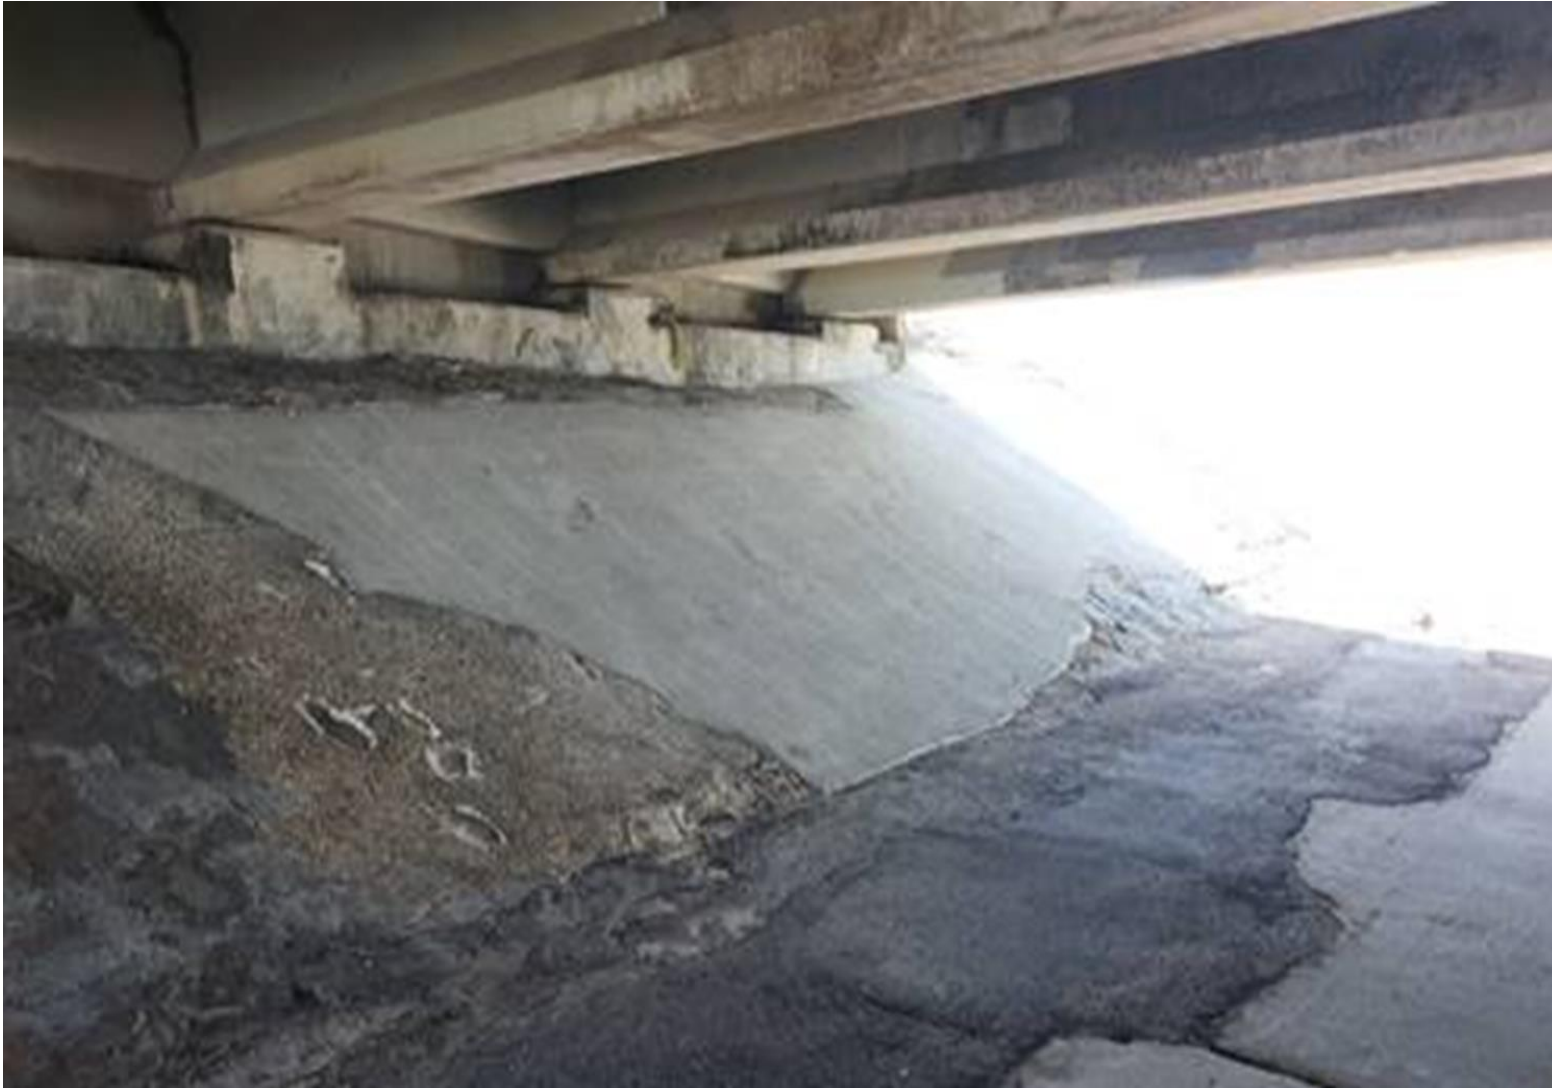
Courtney Campbell Main Bridge

Tropical Storm Eta (2020)

Slope Repair

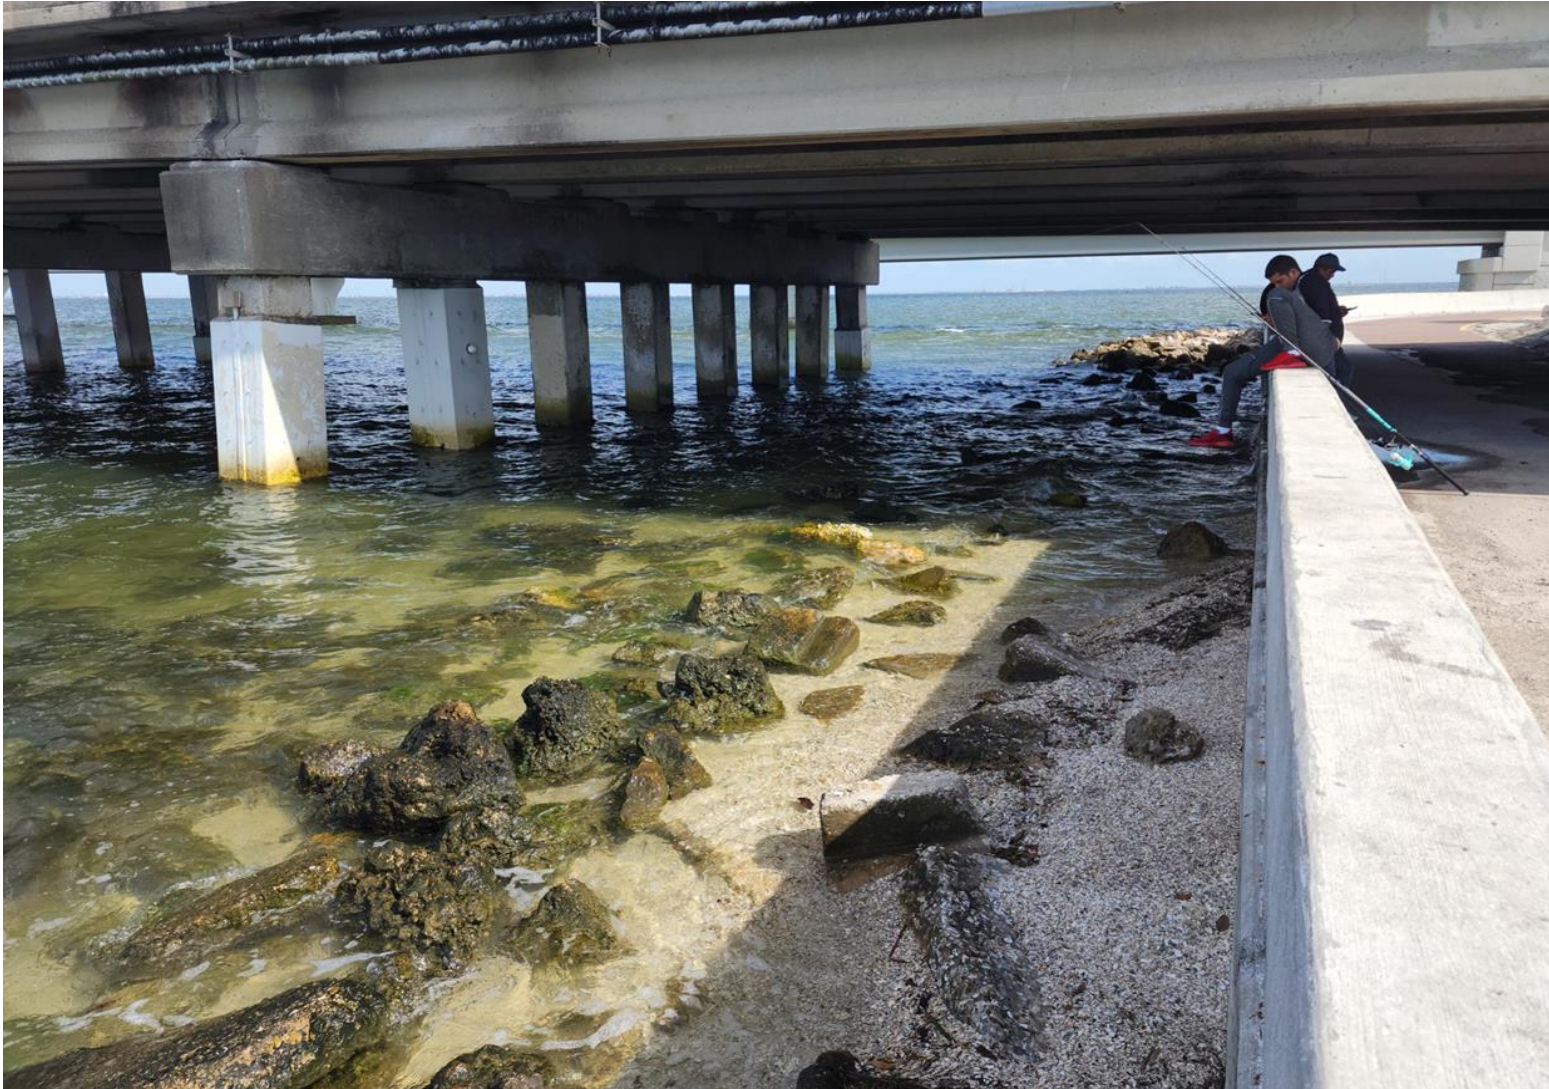
Courtney Campbell Main Bridge

Tropical Storm Eta (2020)

Displacement of
rubble riprap protection

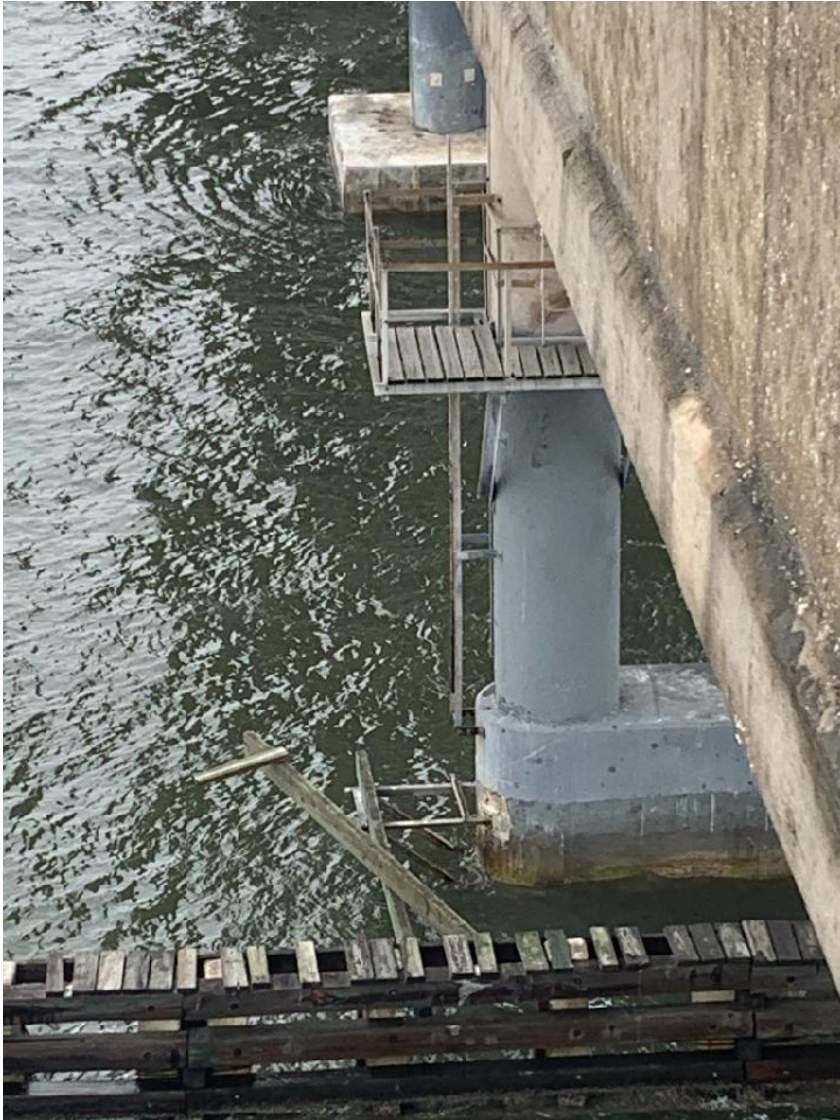
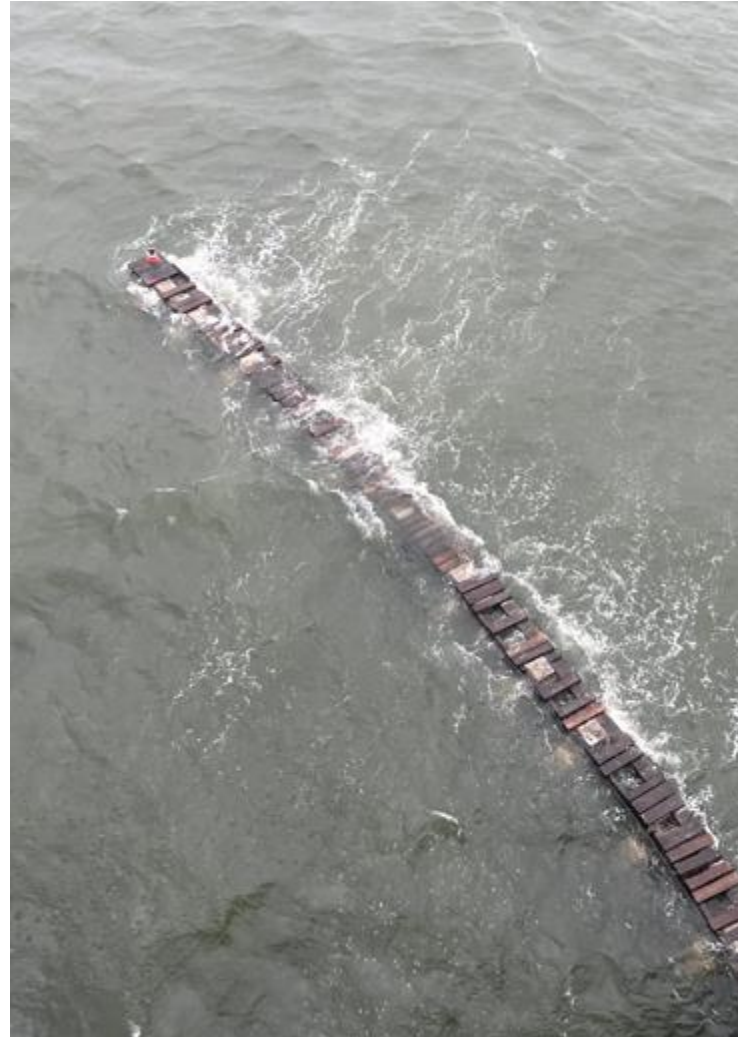
Courtney Campbell Main Bridge

Hurricane Idalia (2023)

- Fender system damage
- Will be repaired via Emergency Contract

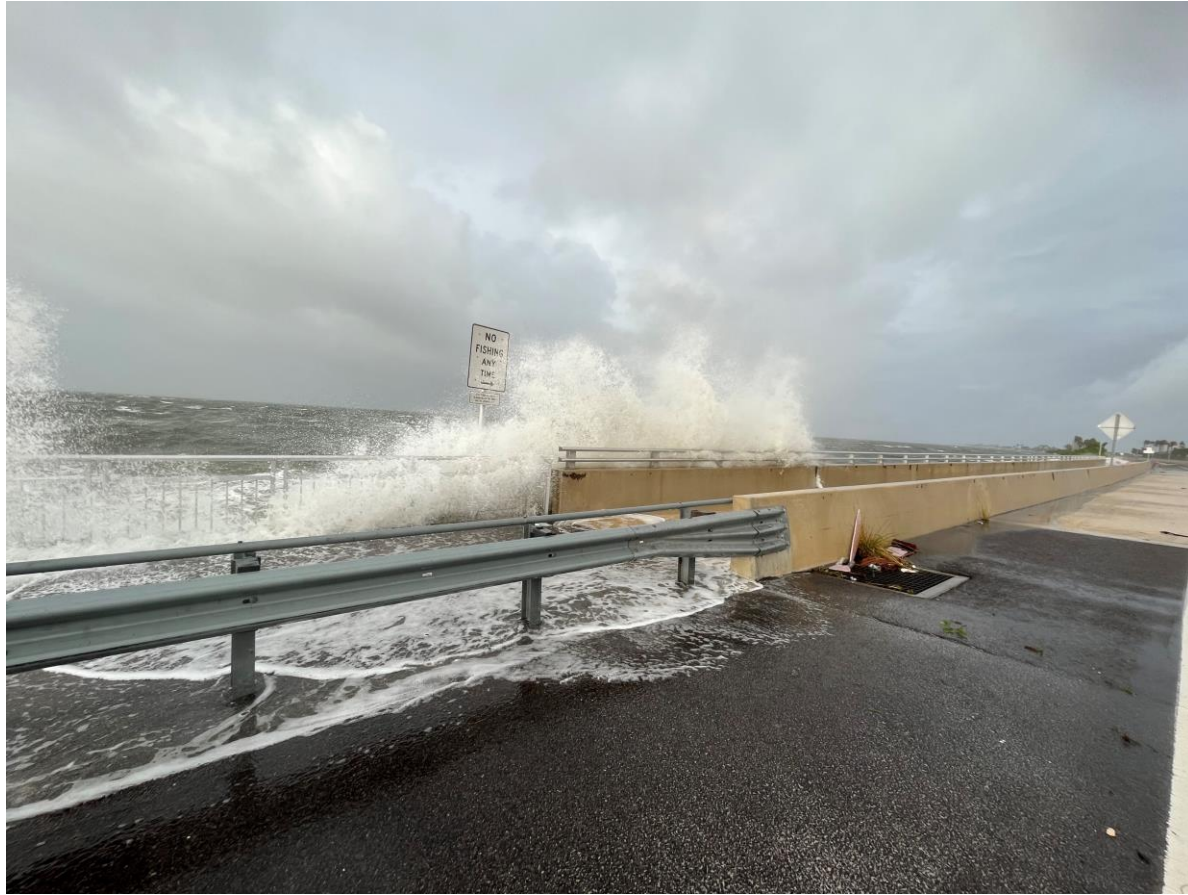
Courtney Campbell V.C. Bridge

Hurricane Idalia (2023)

- Damage to gravity wall and concrete cap/seawall
- Undermining
- Will be repaired via Emergency Contract
