# Courtney Campbell Causeway Vulnerability Assessment and Resiliency Study

November 6, 2023

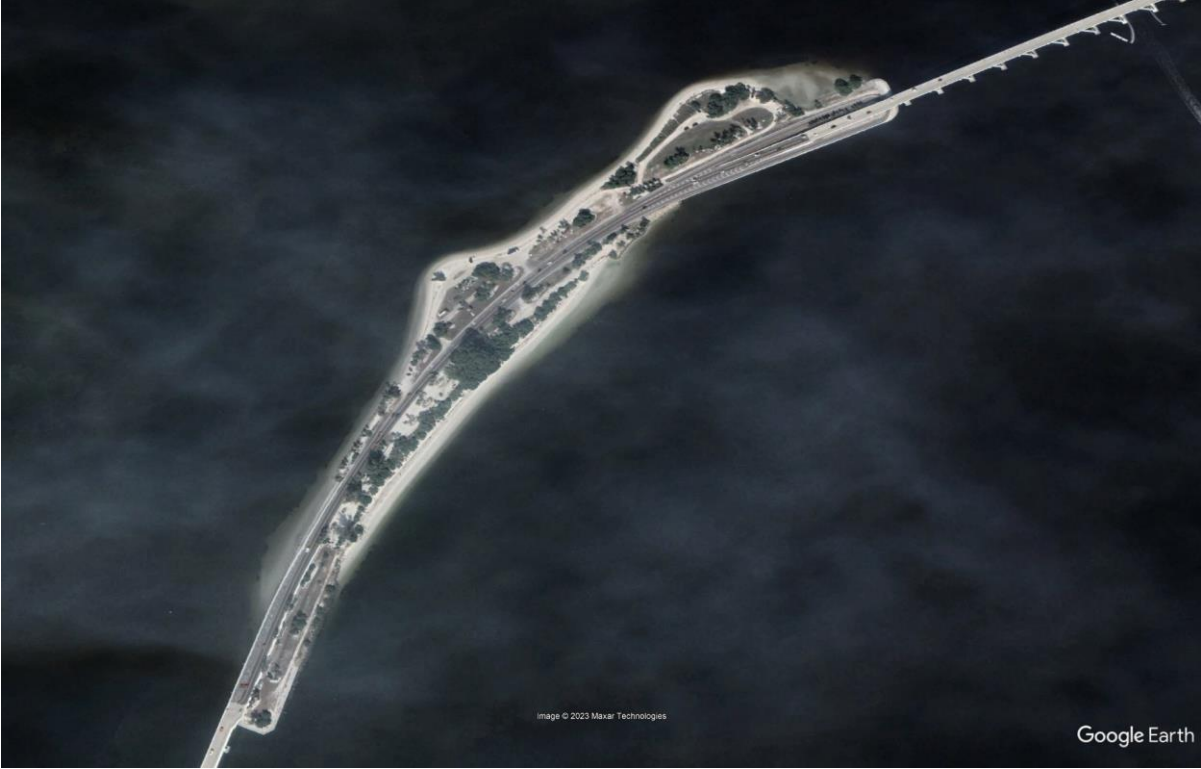
Before Hurricane Ian

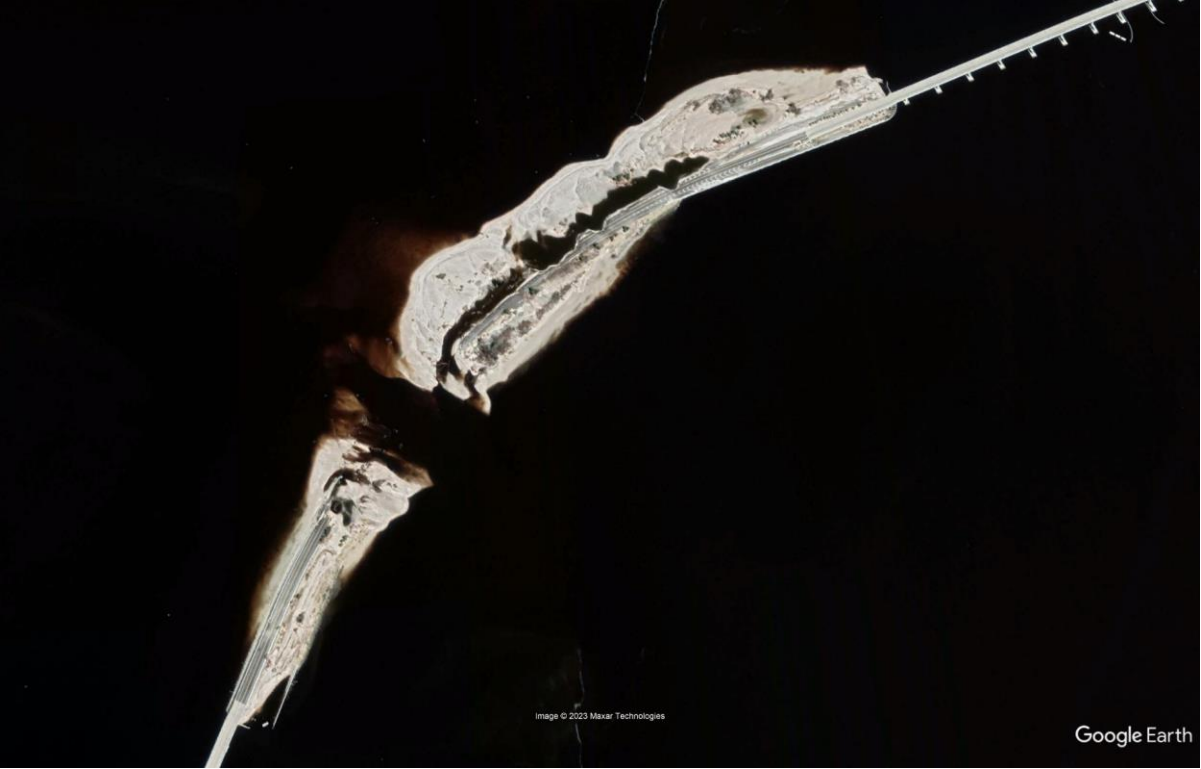
After Hurricane Ian

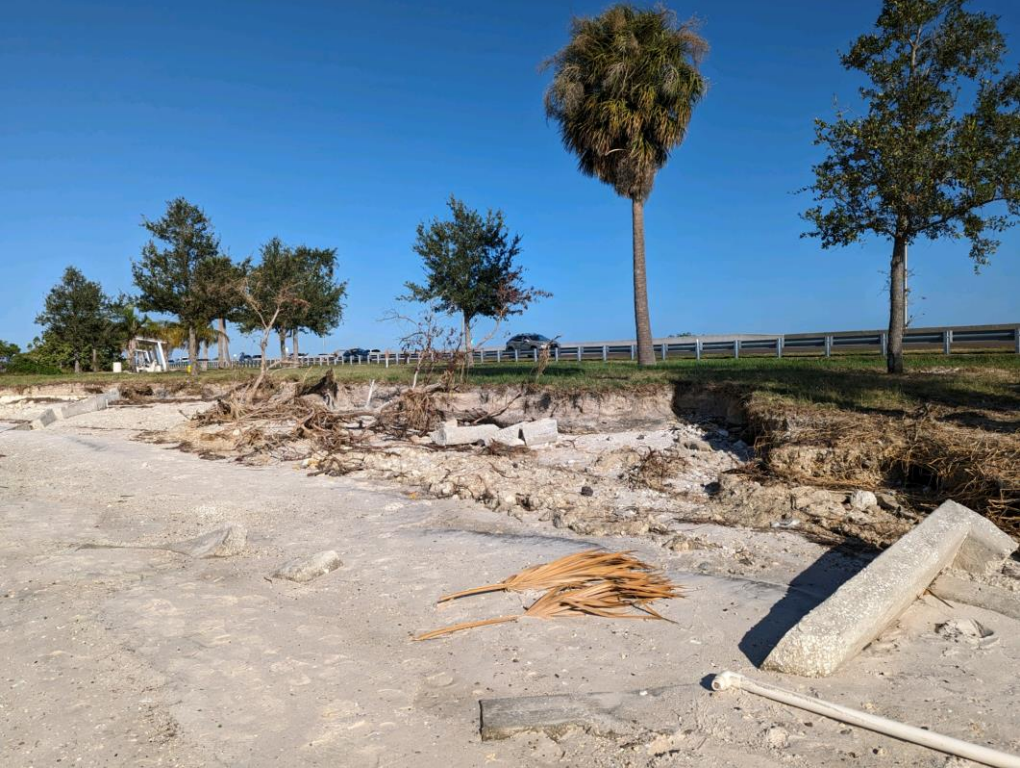
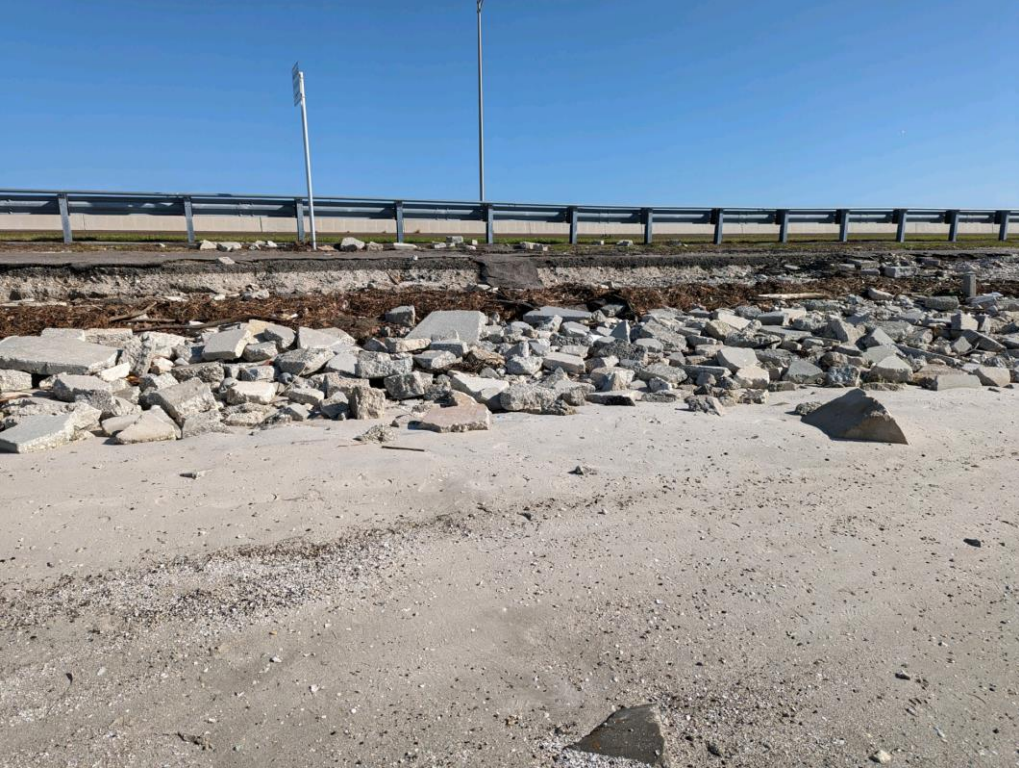
# Motivation – Existing Erosion near Ben T Davis Beach

Photos taken October 26, 2023

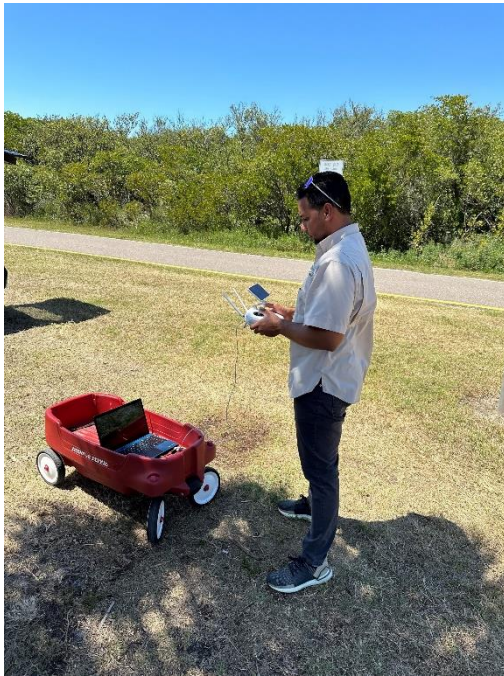
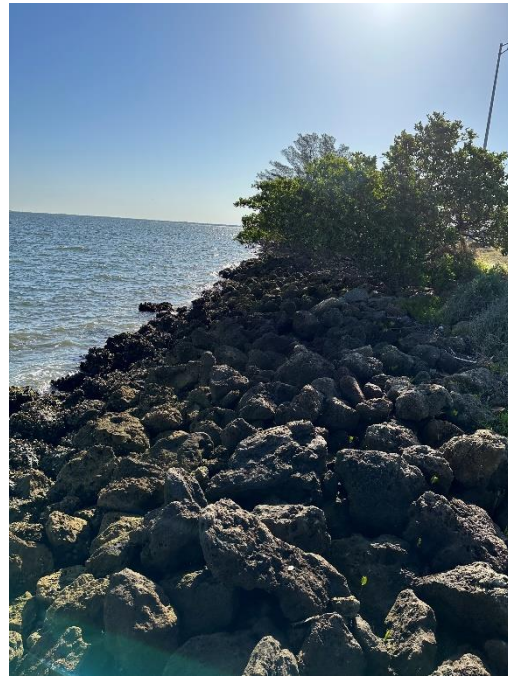
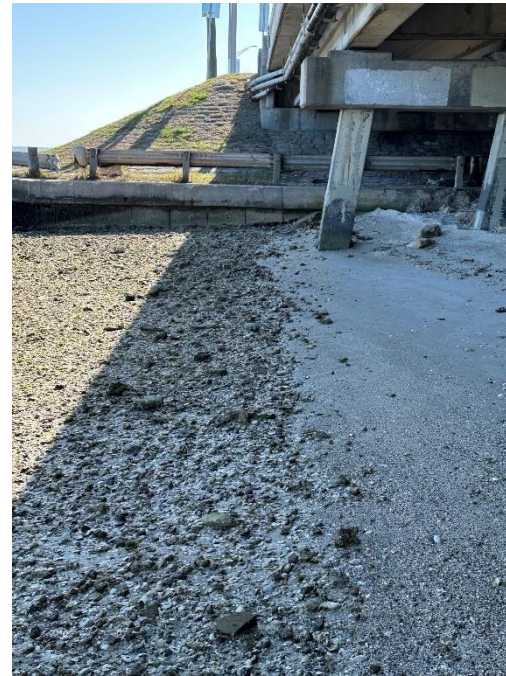
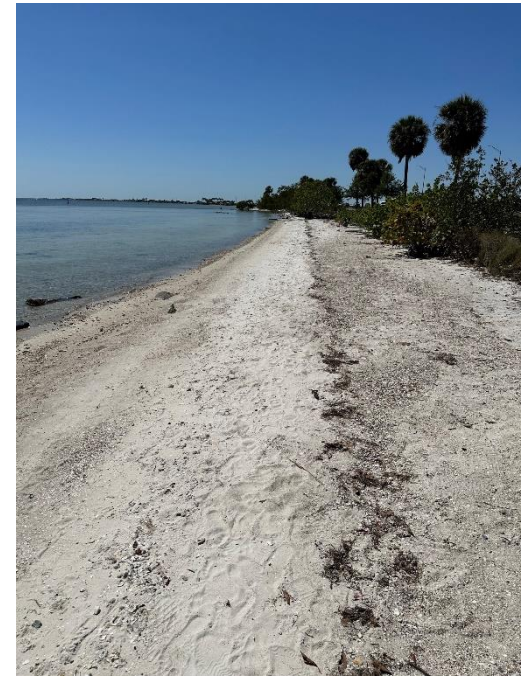
- Drone imagery and mapping performed for most of causeway (3,500+ aerial images)
- Visited critical areas and took pictures (beach areas, boat ramp, and west bridge)
- Measured sample rock sizes at various locations (typical stone size 1.5-2 ft)

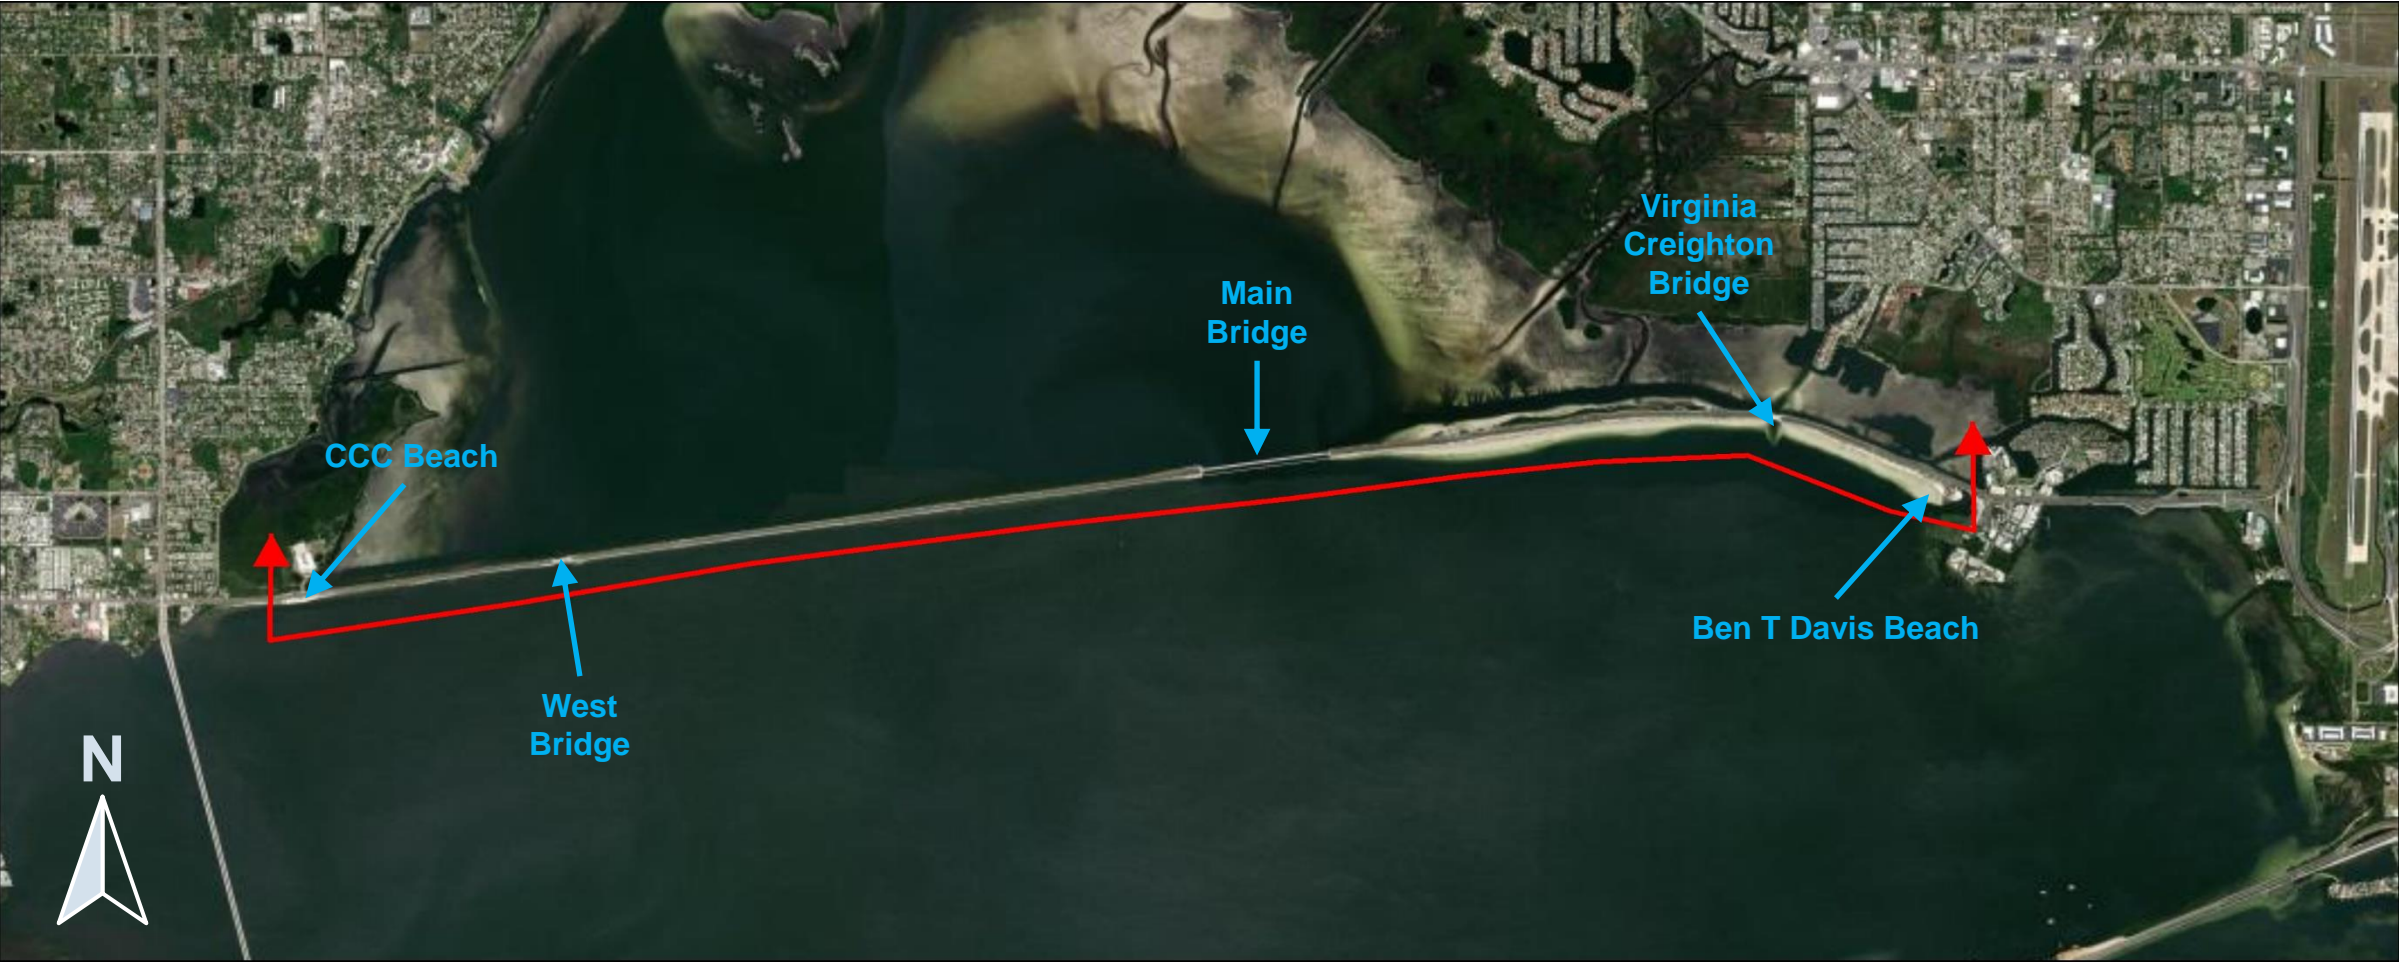
# Profile View of Storm Surge and Wave Hazards

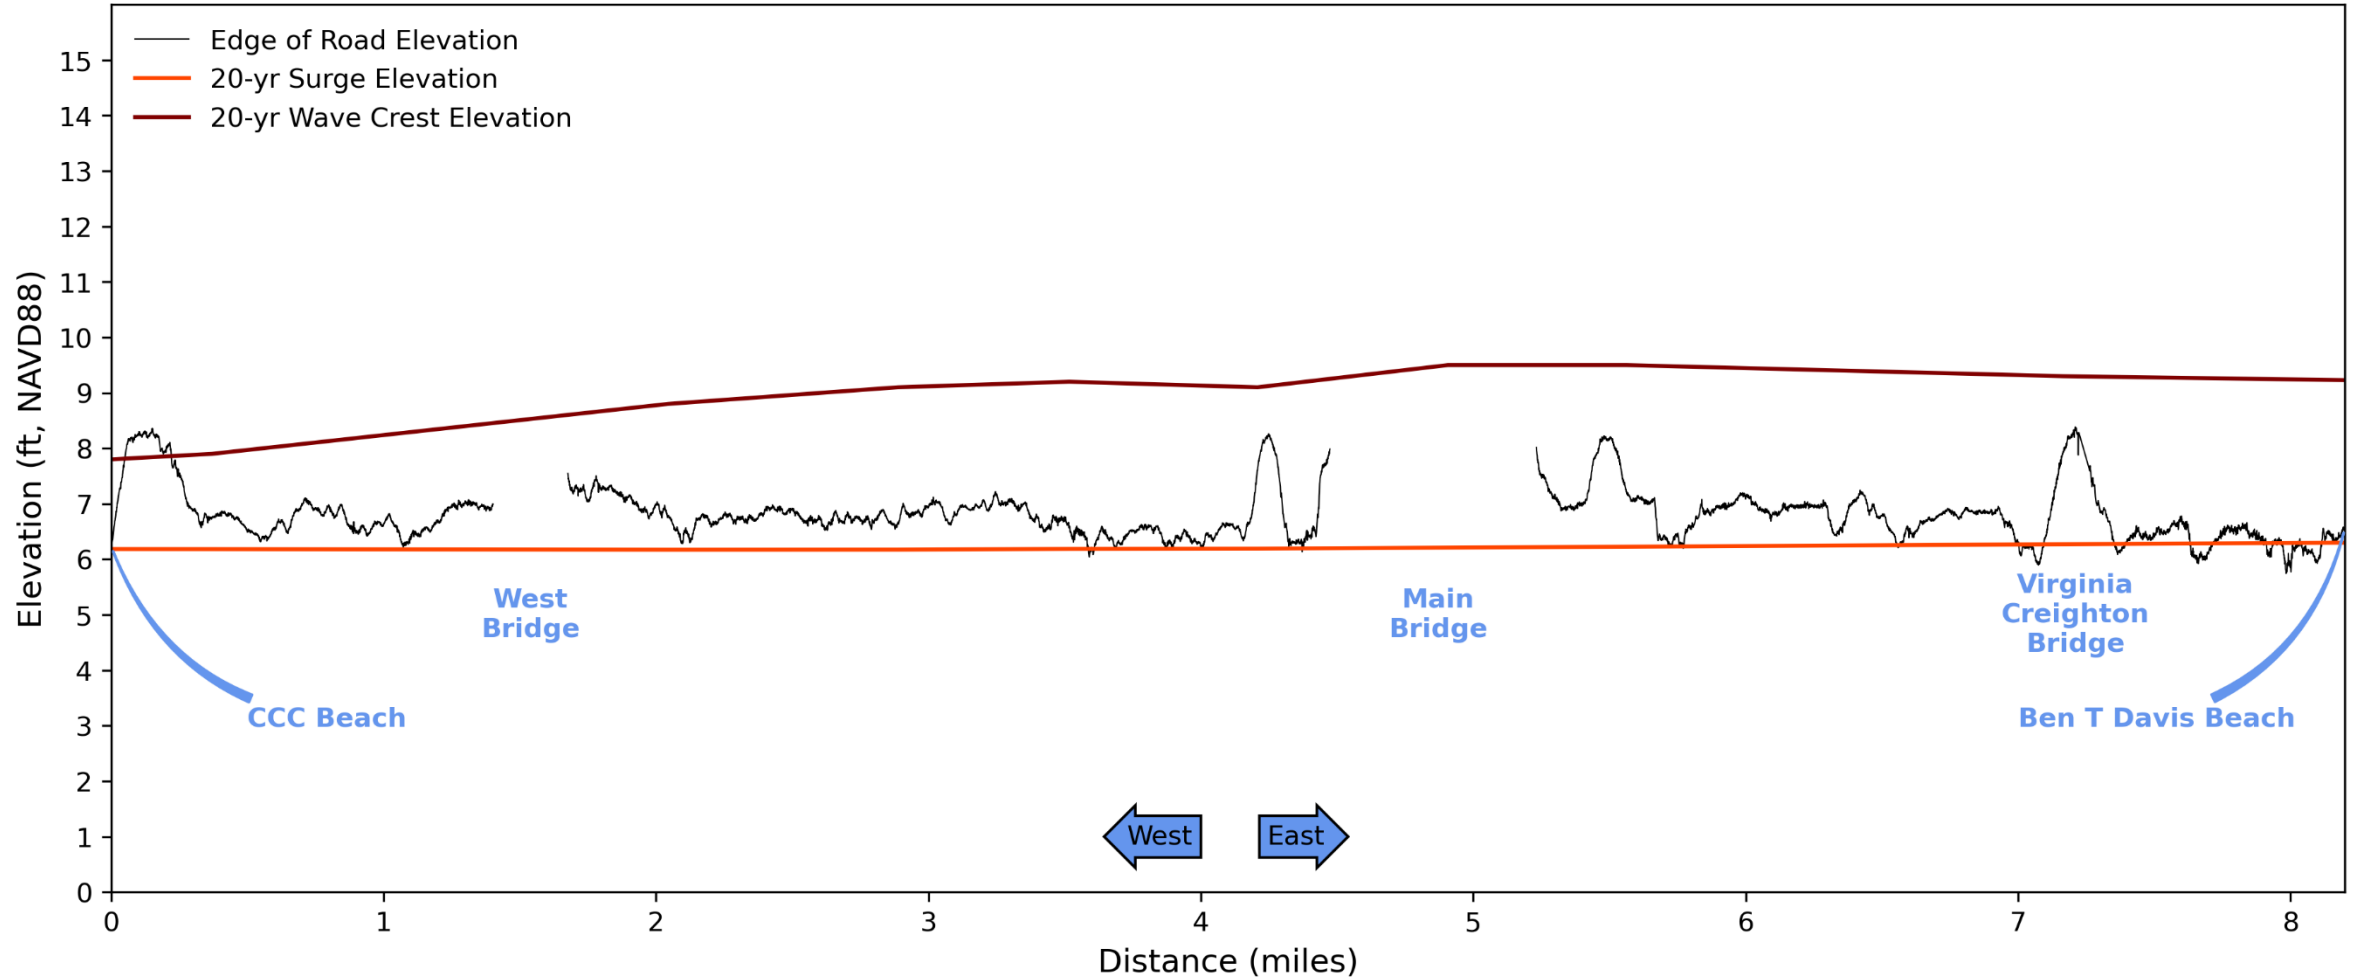
# Profile of Storm Surge and Wave Hazards along Courtney Campbell Causeway (looking south to north)

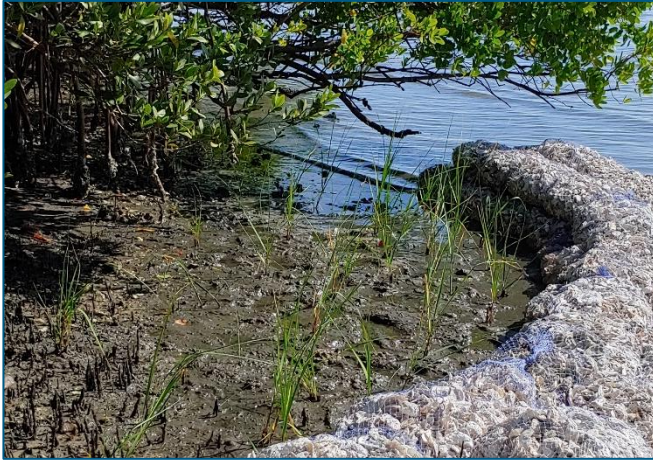
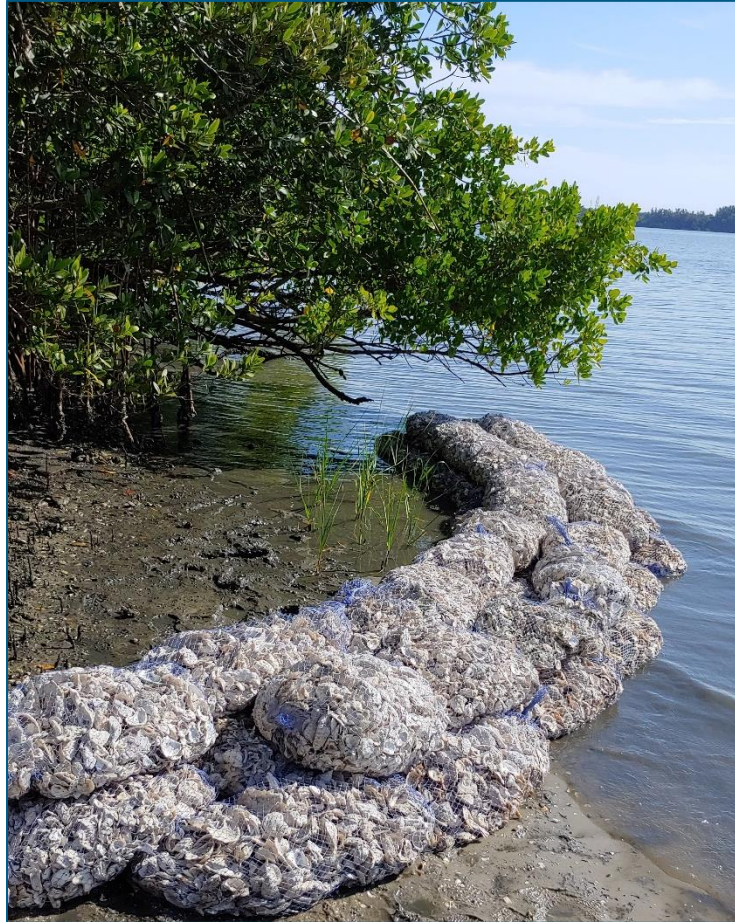
Marsh sills

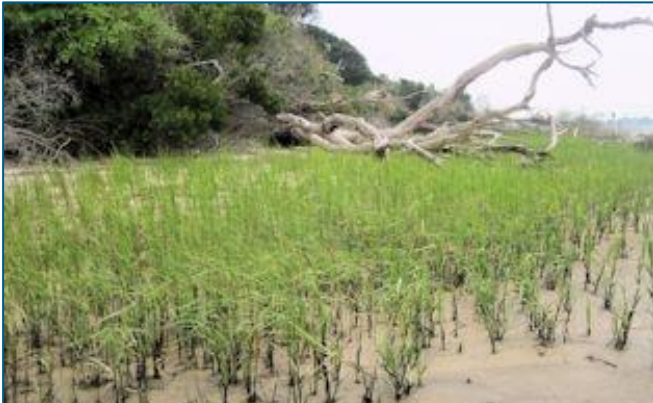
Vegetative plantings

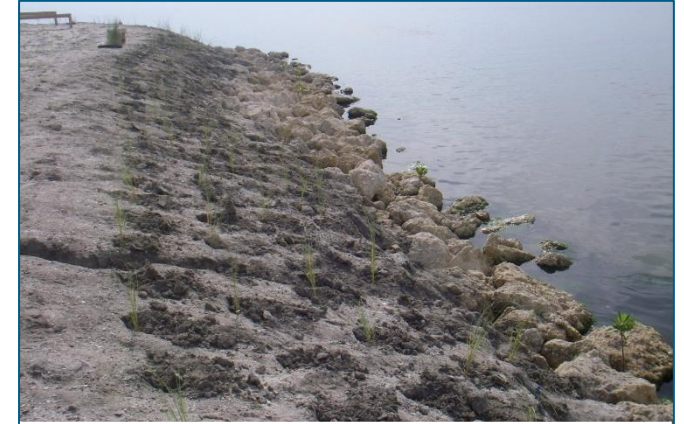
Immediately post-construction

Bank grading with vegetative plantings

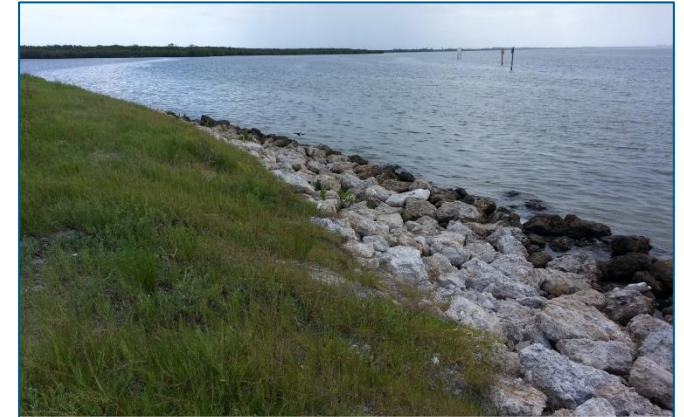
One year after construction

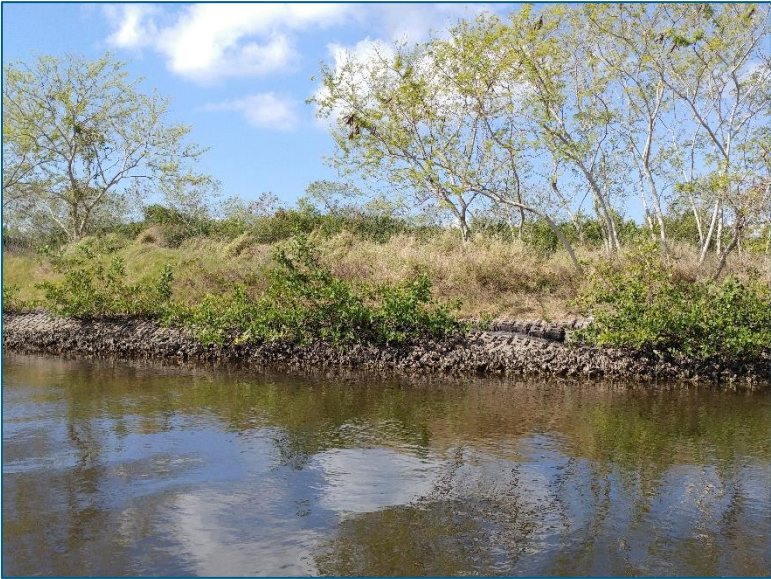
Articulated concrete blocks (ACBs) with vegetative plantings

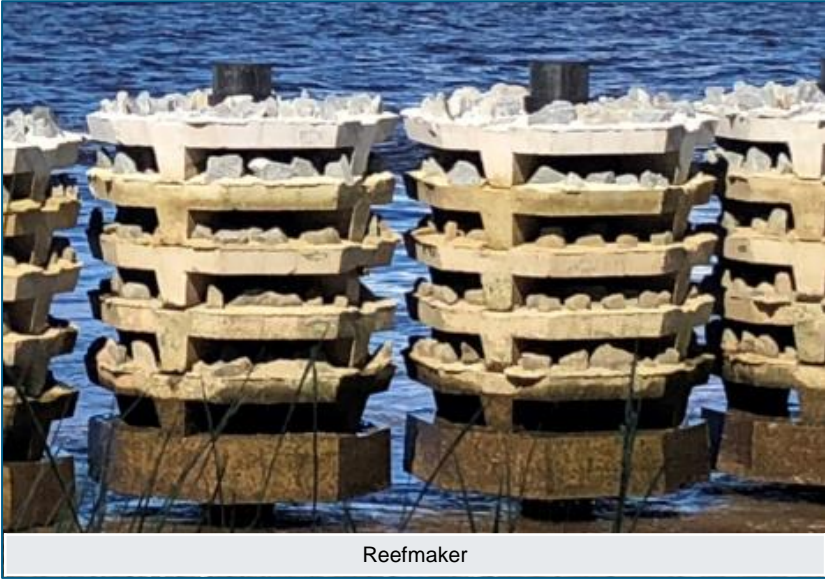
Reefmaker

Wave attenuation devices (WADs)

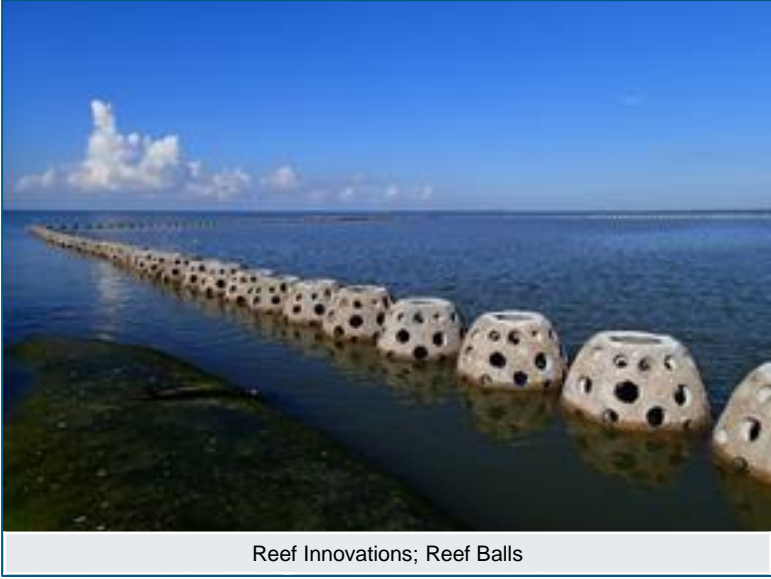
Reef Innovations; Reef Balls

Oyster breakwater

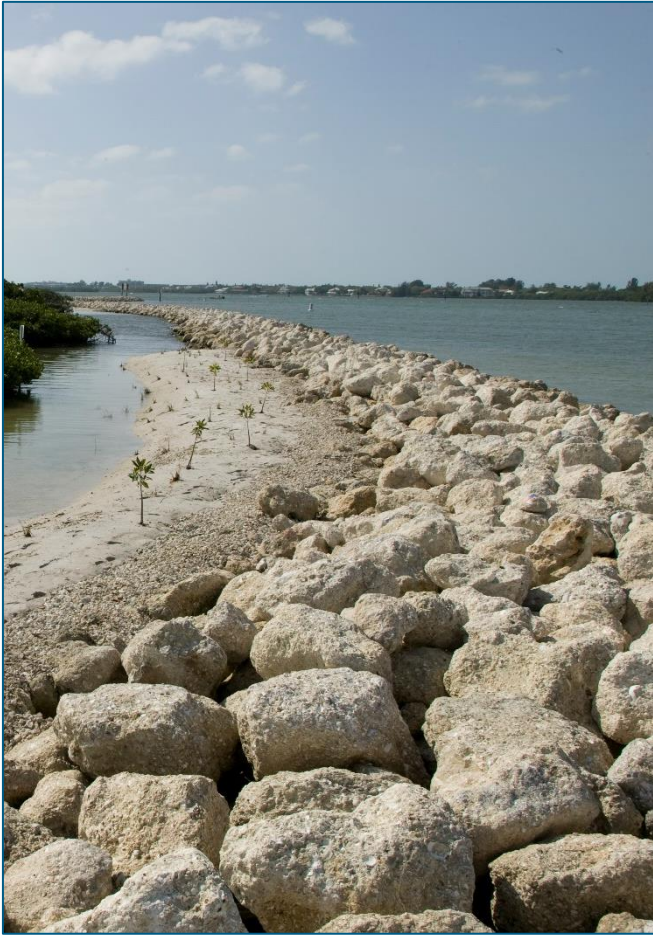
Breakwater with vegetative plantings

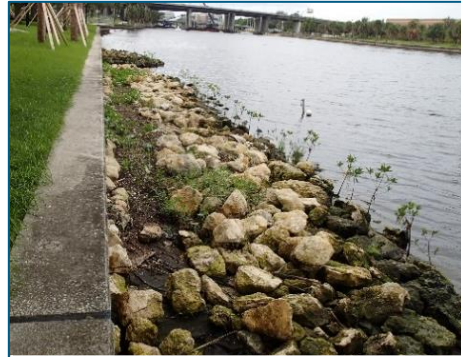
Pre-planting establishment

Planted revetment

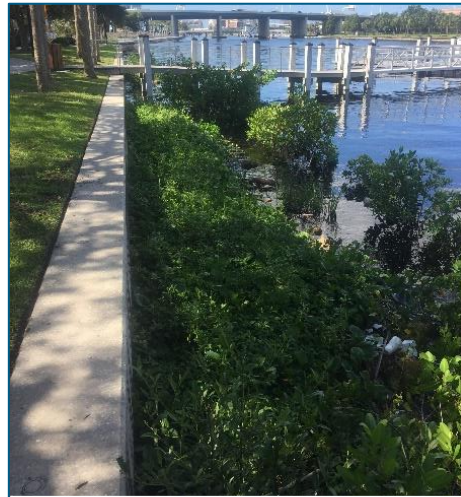
Post-planting establishment

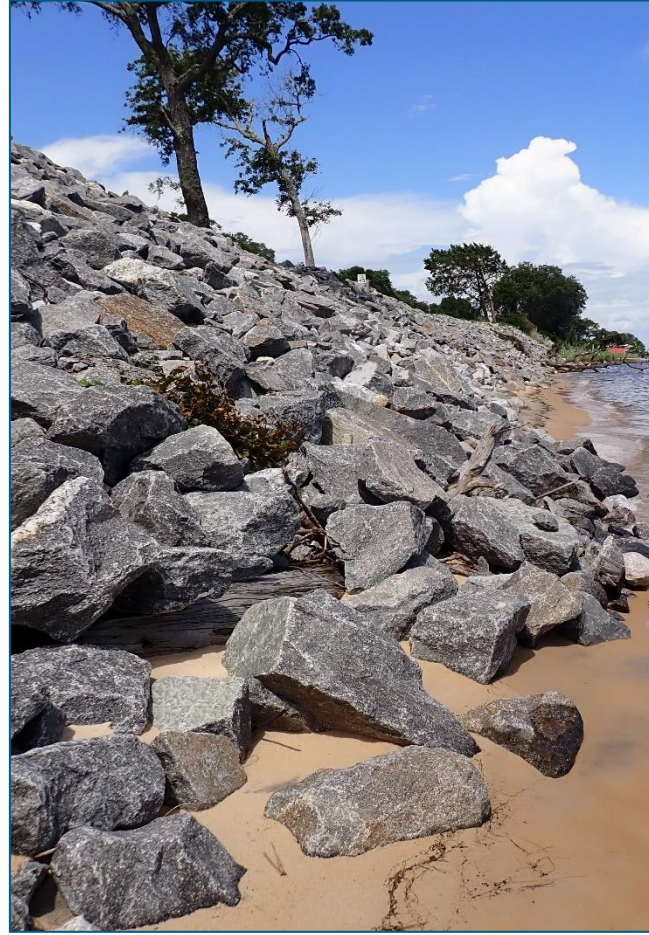
Stone revetment

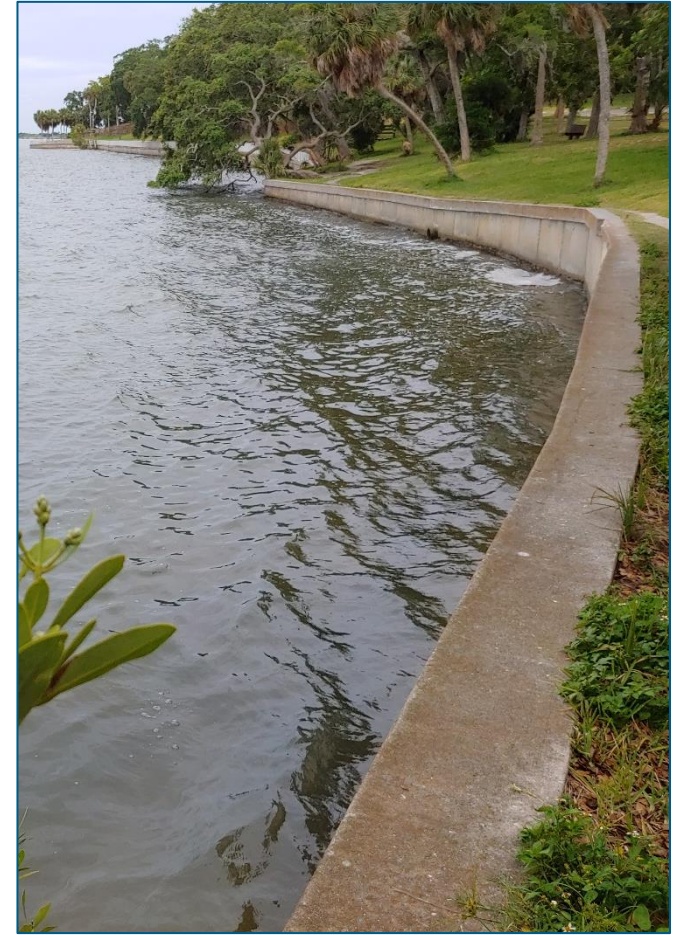
Seawall
