Vision Zero Corridor Study

78th Street

FINAL REPORT

78TH STREET VISION ZERO CORRIDOR STUDY

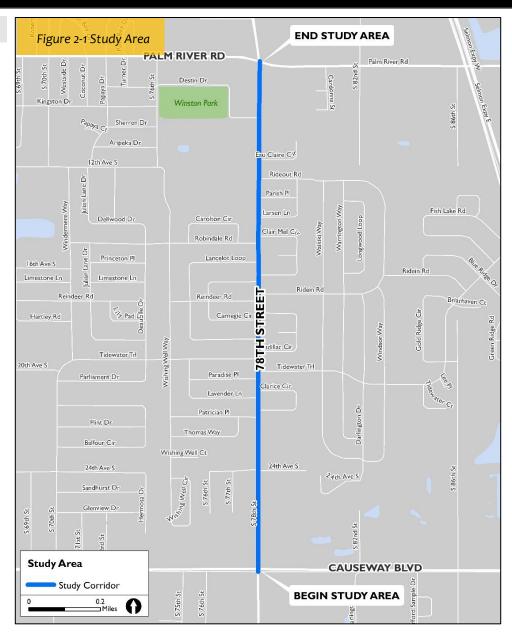
78th Street is a north-south roadway located in Hillsborough County, Florida. The study limits of the 78th Street corridor are from Causeway Boulevard to Palm River Road. It is functionally classified as an **Urban Collector** and is approximately **1.25 miles** long. The local jurisdiction for the 78th Street corridor is Hillsborough County. See **Figure 2-1** for the project area study limits.

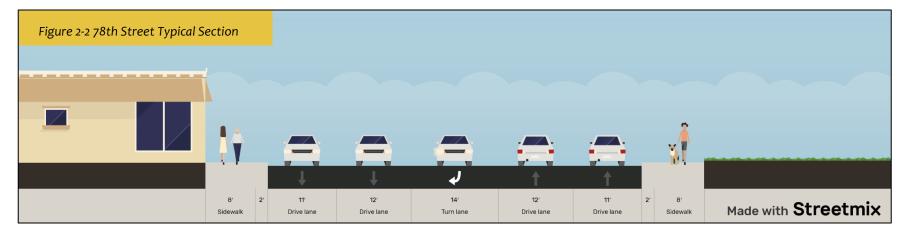
78TH STREET CORRIDOR TYPICAL SECTION

- The FDOT functional classification is Urban Collector.
- Within the **Urbanized Area** as classified by the Federal Highway Administration (FHWA).
- Within the Urban Service Area for Hillsborough County.
- 78th Street is a four-lane facility with a center, two-way left turn lane.
- The posted speed limit along the corridor is 45 mph.
- Sidewalks are present along both sides throughout the length of the corridor.
- There are no on- or off-street bicycle facilities.
- Street lighting is present through portions of the corridor.
- There is one school zone located along the corridor.
- Crosswalks are present at three locations.

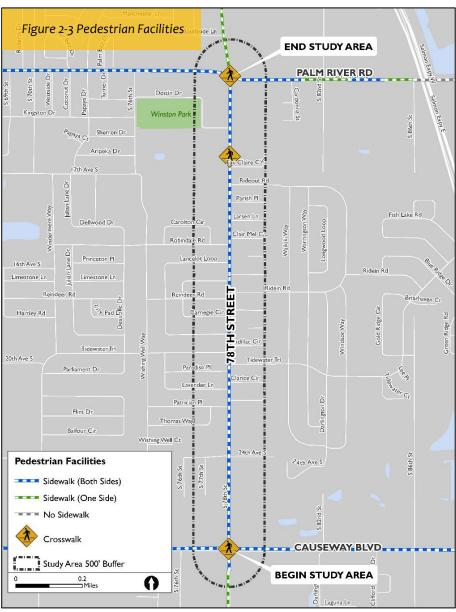
Sidewalks are present on both sides along the length of the corridor. 78th Street sidewalks connect on both sides of the roadway along Causeway Boulevard and Palm River Road. Sidewalks are present only on the west side of 78th Street to the north and south of the corridor. There is an approximately three-foot strip of either grass or pavement between the sidewalk and the travel lanes.

There are three marked and signalized pedestrian crossings along the corridor located at 78th Street and Palm River Road, 78th Street and Causeway Boulevard, and a midblock crossing in front of Clair Mel Elementary School and the Palm River Medical Center just north of Eau Claire Circle. The midblock crossing is approximately 0.25 miles south of Palm River Road and 1 mile north of Causeway Boulevard.

Figure 2-3 displays the locations of the sidewalks and crosswalks along the corridor.

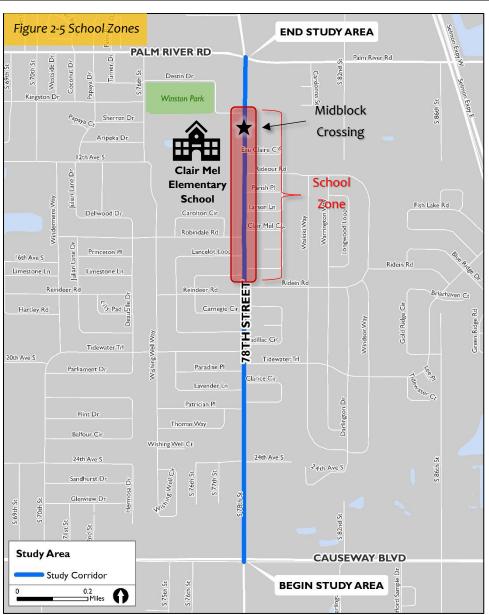
Elementary School from north of Rideout Road to north of Destin Drive. The approximate school zone limits are shown in **red** in **Figure 2-5**. The school zone limits are indicated by pavement markings on the northern and southern limits and timed, flashing beacons decreasing the speed limit to 20 mph.

The midblock crossing to access the school is located between Eau Claire Circle and Destin Drive. It is shown as a star in **Figure 2-5**.

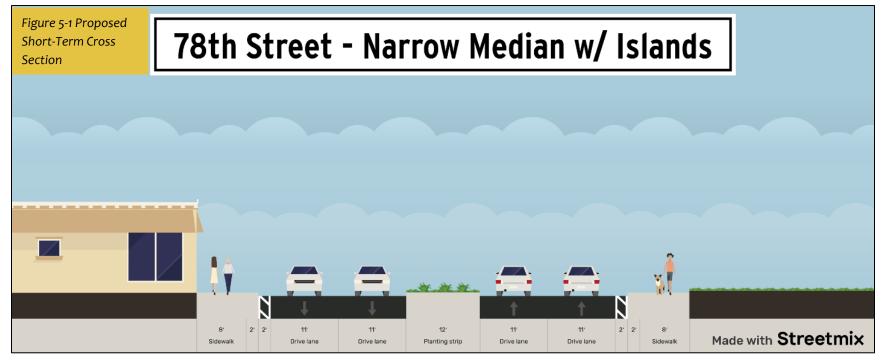
The proposed cross-section shown in **Figure 5-1** for the corridor includes narrowing travel lanes to 11 feet, maintaining the center two-way left turn lane but implementing intermittent median islands, and adding a 2-foot paved shoulder on each side.

The proposed typical cross section was used as a prototype for developing the conceptual layout for the whole 78th Street corridor. The concept demonstrates the proposed restriping within the existing pavement width, proposed sidewalk gap installations, and median changes such as channelization islands. The plan view concept can be found in the appendix.

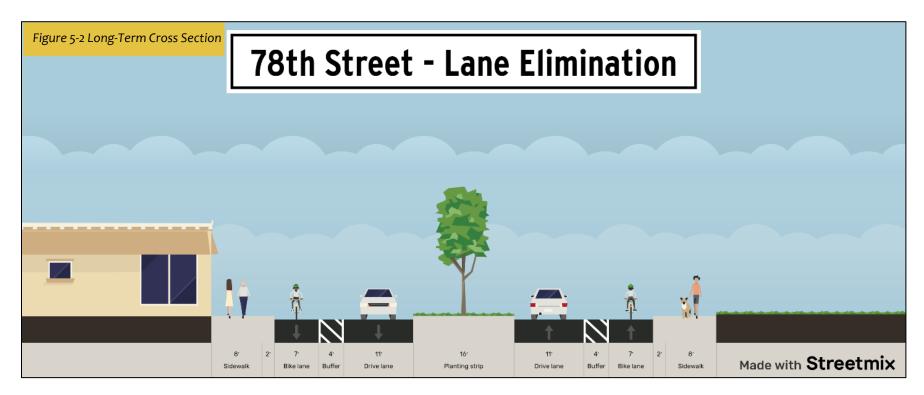
ALTERNATIVE 2 CROSS SECTION

As an alternative to incrementally improving the pedestrian and bike environment, and based on the review of traffic data and consulting with agency partners, a lane elimination along 78th Street may be a viable option to enhancing safety for all road users, including pedestrians, bicyclists, and motorists.

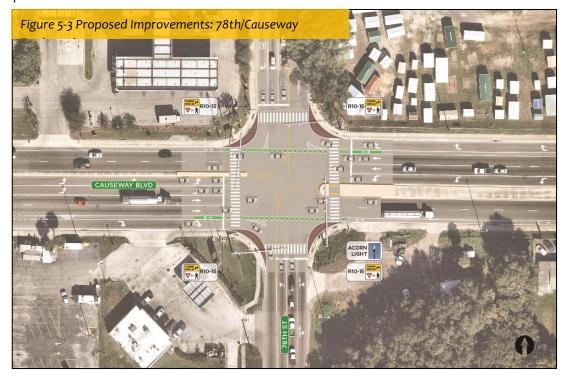
- <u>Bike lane extensions:</u> To minimize vehicle encroachment into the path of bicyclists, dashed green bike lane extensions are proposed through the intersection.

- Pedestrian refuge areas: The intersection approaches along Causeway Boulevard include concrete medians. By extending the median closer into the intersection, while being mindful of the design vehicle path, pedestrian refuge areas can be provided. An

- additional enhancement to the median at the eastern approach would be to consider a two-stage crossing with pedestrian countdown signals in the median. While the concrete median at the western approach of Causeway is too narrow to implement a full pedestrian refuge, the median nose has been extended beyond the sidewalk to delineate the turning vehicle path and provide separation from crossing pedestrians.

- Skip pavement marking extensions: Adding skip markings in the intersection will help guide turning vehicles and reduce confusion.
- Semi-permanent curb extensions: Curb extensions are a proven safety countermeasure³ that enhances pedestrian safety and comfort at intersections. By reducing the speeds of turning vehicles, shortening the crossing distance, and increasing visibility, curb extensions also encourage pedestrians and bicyclists to cross at designated locations⁴. A semi-permanent curbextension installation that provides a safer

- environment for pedestrians while allowing turning vehicle maneuvers can consist of stamped/painted asphalt, a raised concrete apron, as well as ceramic domes and/or bollards. The bollards can be placed so as to narrow the curb radius while allowing for a truck apron for larger vehicles to mount as needed.
- Signage: To manage right turning vehicles and further protect people crossing at the intersection, it is recommended that MUTCD sign R10-15 "Turning Vehicles Yield to Pedestrian" signs are installed at all four corners. Figure 5-3 depicts these signs as postmounted at each corner, however, overhead or blank out signs can also be considered.

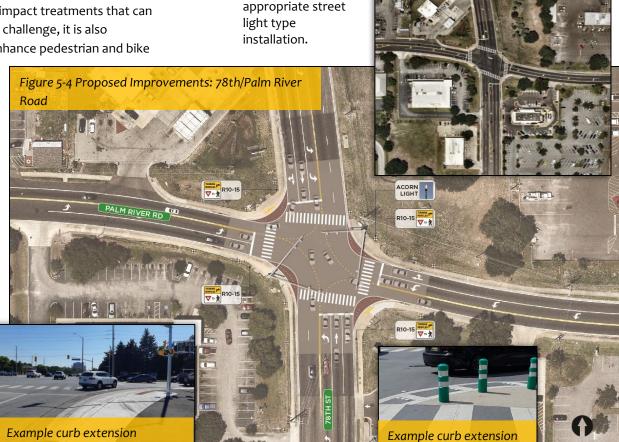
- Skip pavement marking extensions: Adding skip markings to this intersection is especially needed given its skewed geometry.
- Curb extensions: Curb extensions should be installed at all corners of this intersection to alleviate the offsets created by the skewed geometry. With the proposed configurations, pedestrians are expected to wait at the existing curb ramps, with the curb extensions and bollards serving as additional buffer from turning vehicles. Existing curb ramp conditions should be further evaluated for ADA compliance.

<u>Lighting:</u> a significant number of crashes (18%) occurred during nighttime; therefore, it is important to evaluate and enhance street

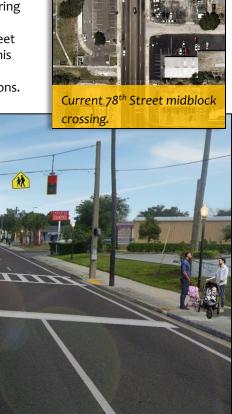
Concrete median: The current five-lane undivided section of 78th Street is not conducive to a safe pedestrian crossing environment. While the turn lane is needed to facilitate turning onto side streets, designated pedestrian crossings along 78th Street would benefit from a raised concrete or landscaped median.

- Pedestrian refuge area: In conjunction with the median island, a pedestrian refuge area should be installed across the median. To facilitate visibility and eye contact between motorists and pedestrians, the pedestrian refuge area can be diagonal.
- <u>Lighting</u>: While only 12% of all crashes occurred during dark conditions, it is recommended that street lighting is installed at this intersection to further enhance safety conditions.

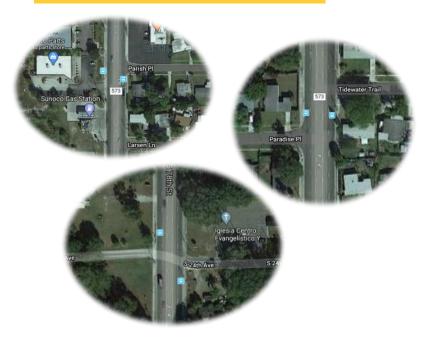
Transit stops along 78th Street

- It provides a refuge area across the five-lane roadway section.
- It can also serve as an aesthetic treatment with lowhedge landscaping that provides more neighborhood context to the corridor.
- Collaboration with transit agencies: In conversation with agency partners, there is an opportunity to discuss consolidating and aligning bus stops along the corridor with the Hillsborough Area Regional Transit Authority. Consolidating, designating, and enhancing transit stops would be beneficial to all road users.

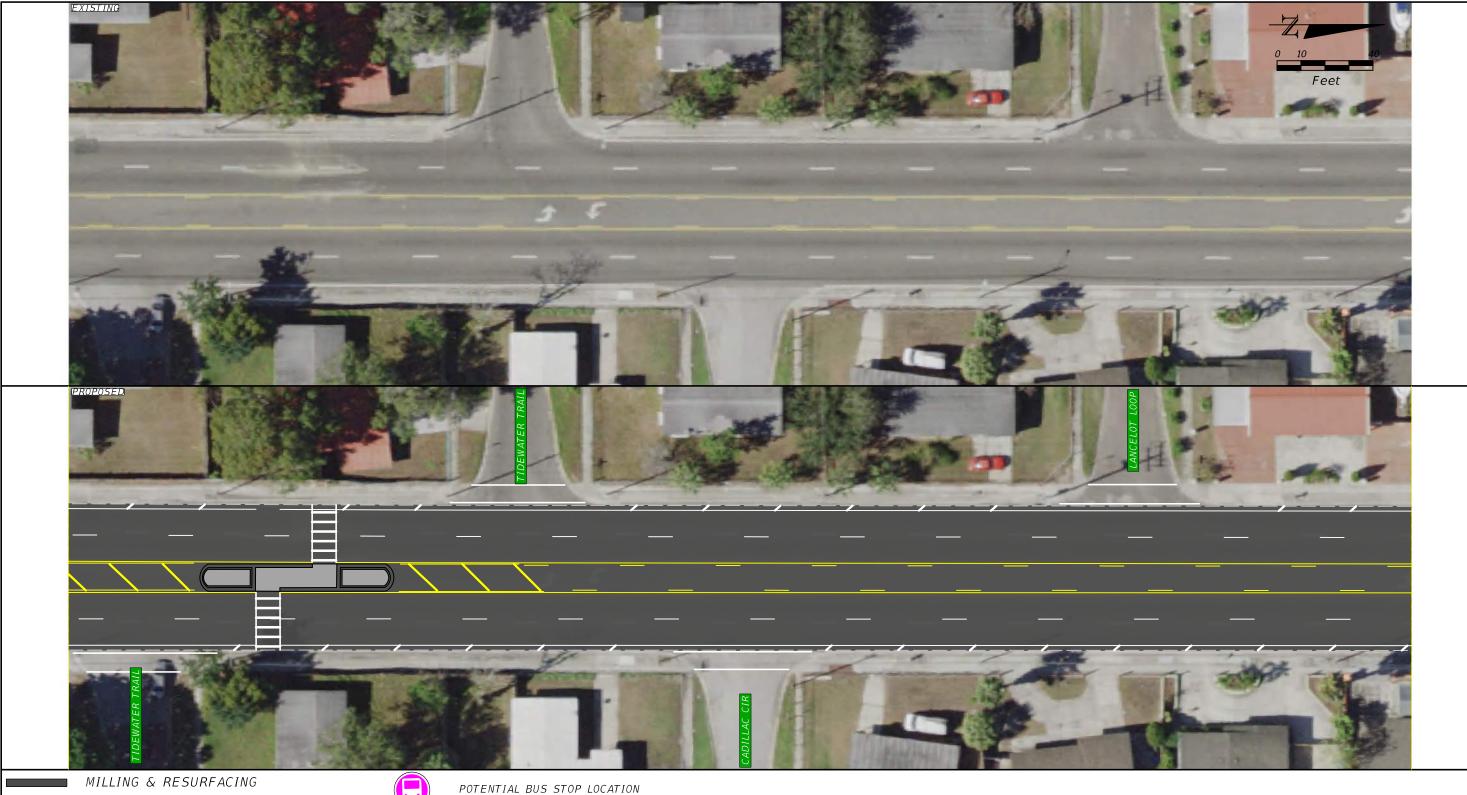
EXISTING BUS STOP LOCATION TO BE RELOCATED

EXISTING BUS STOP LOCATION

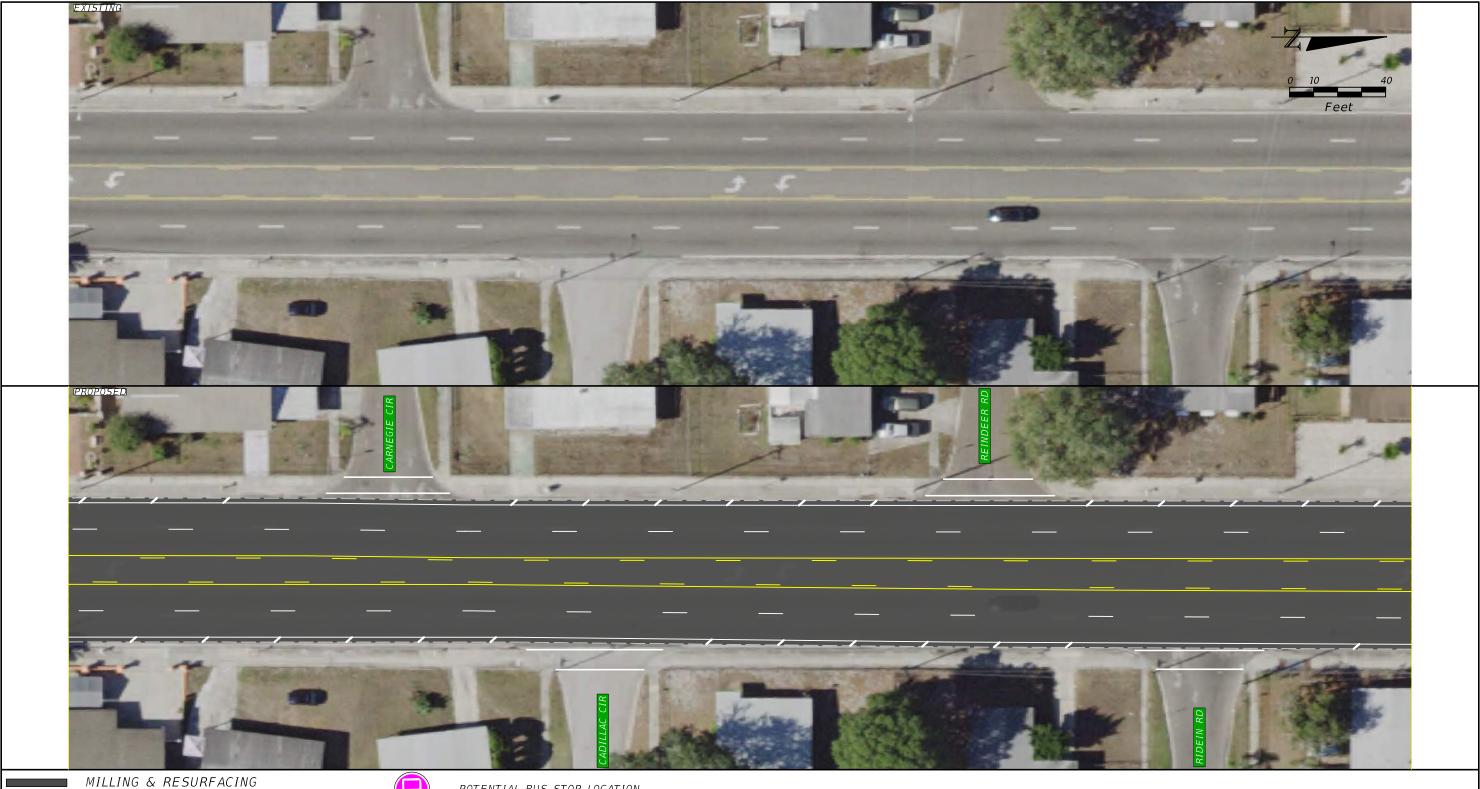
POTENTIAL BUS STOP LOCATION

EXISTING BUS STOP LOCATION

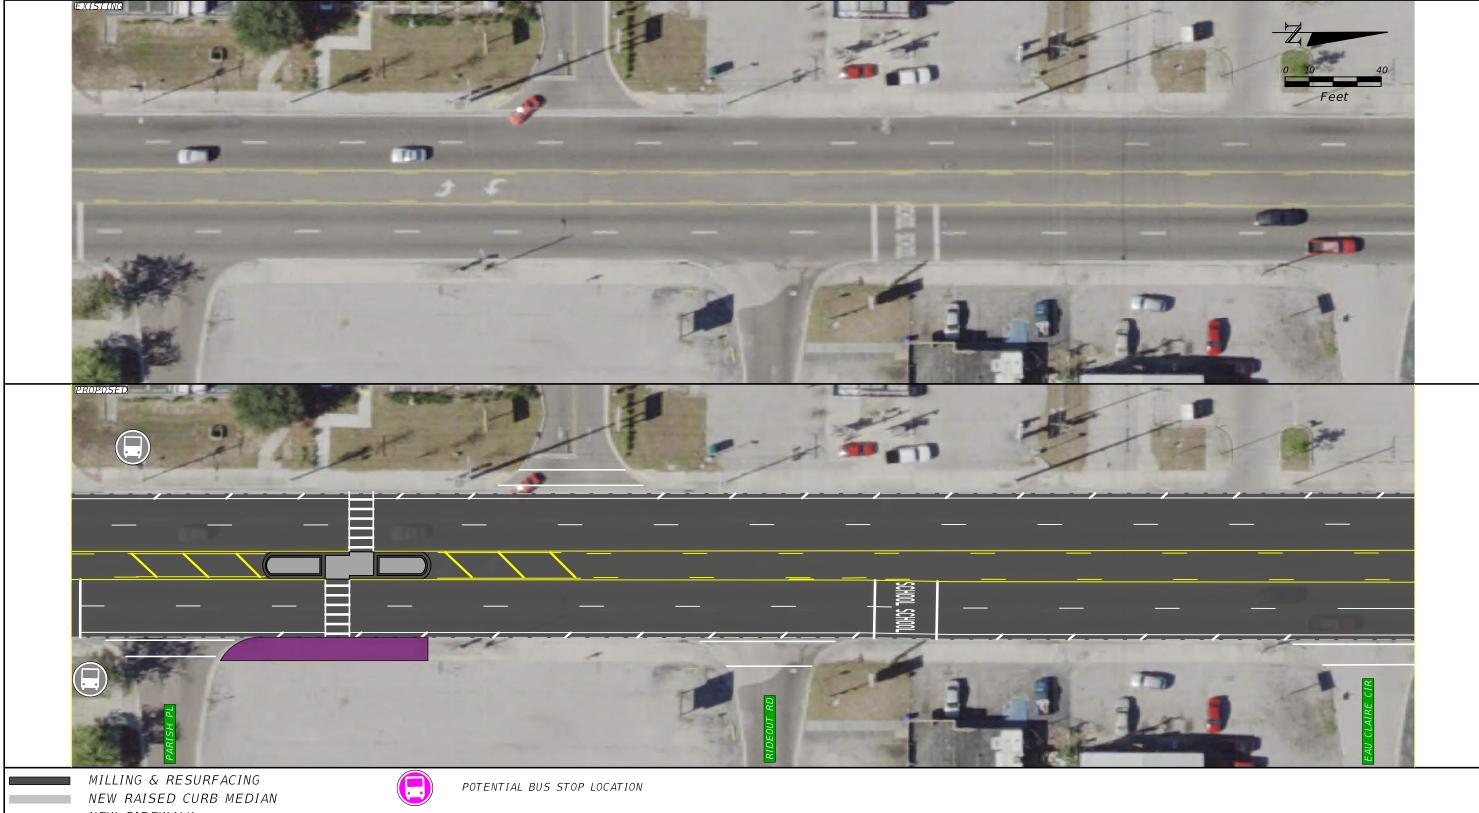
REVISIONS			ST	ATE OF FI	LORIDA	
DATE	DESCRIPTION	DATE	DESCRIPTION	L			NS PORTATION	78TH ST CORRIDOR STUDY
				ROAD N	10. CO	DUNTY	FINANCIAL PROJECT ID	1
				78th 5	ST HILLSB	BOROUGH		CAUSWAY BLVD TO PALM RIVER RD

NEW SIDEWALK NEW RAISED CURB LANDSCAPE MEDIAN

EXISTING BUS STOP LOCATION TO BE RELOCATED

EXISTING BUS STOP LOCATION

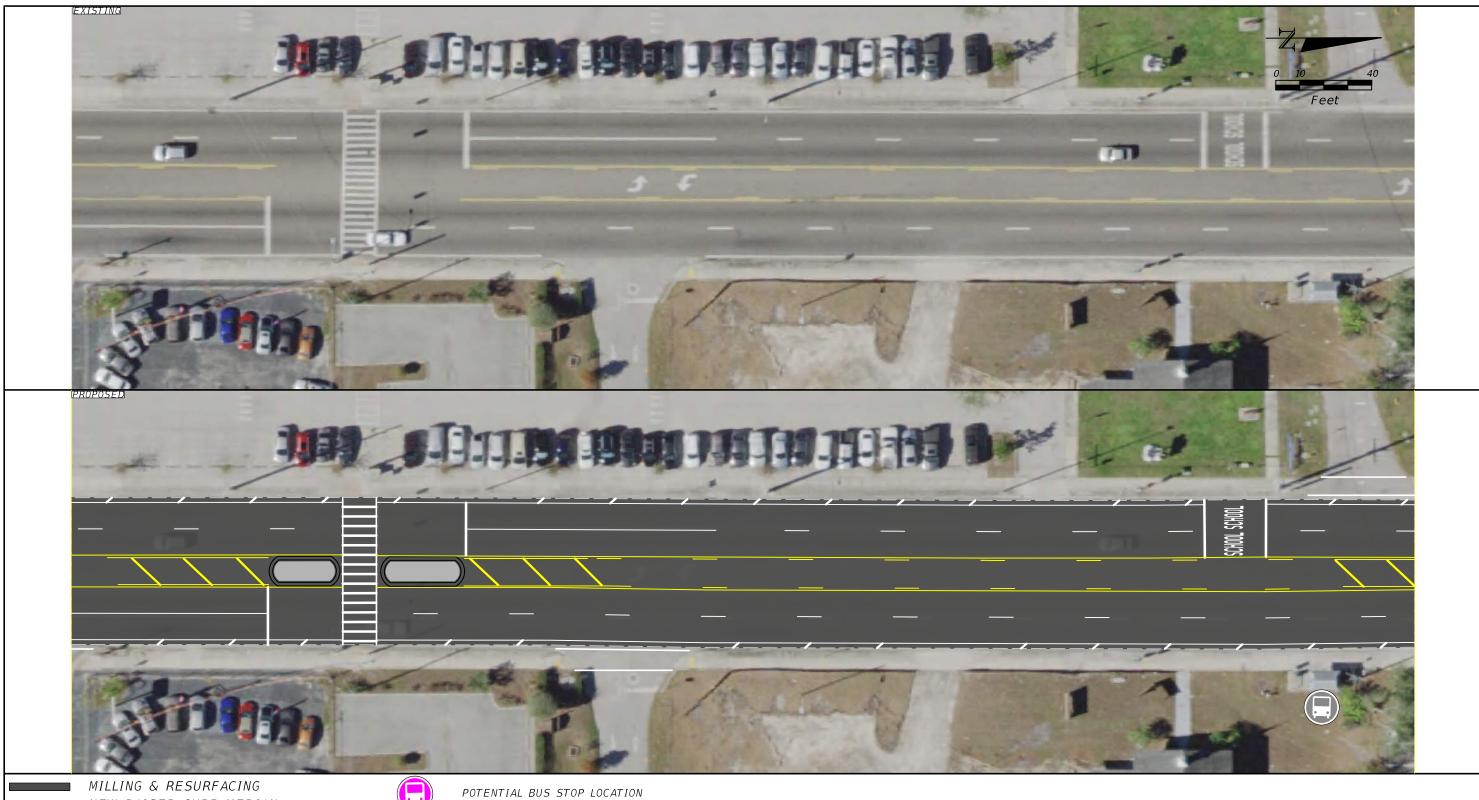
EXISTING BUS STOP LOCATION TO BE RELOCATED

EXISTING BUS STOP LOCATION

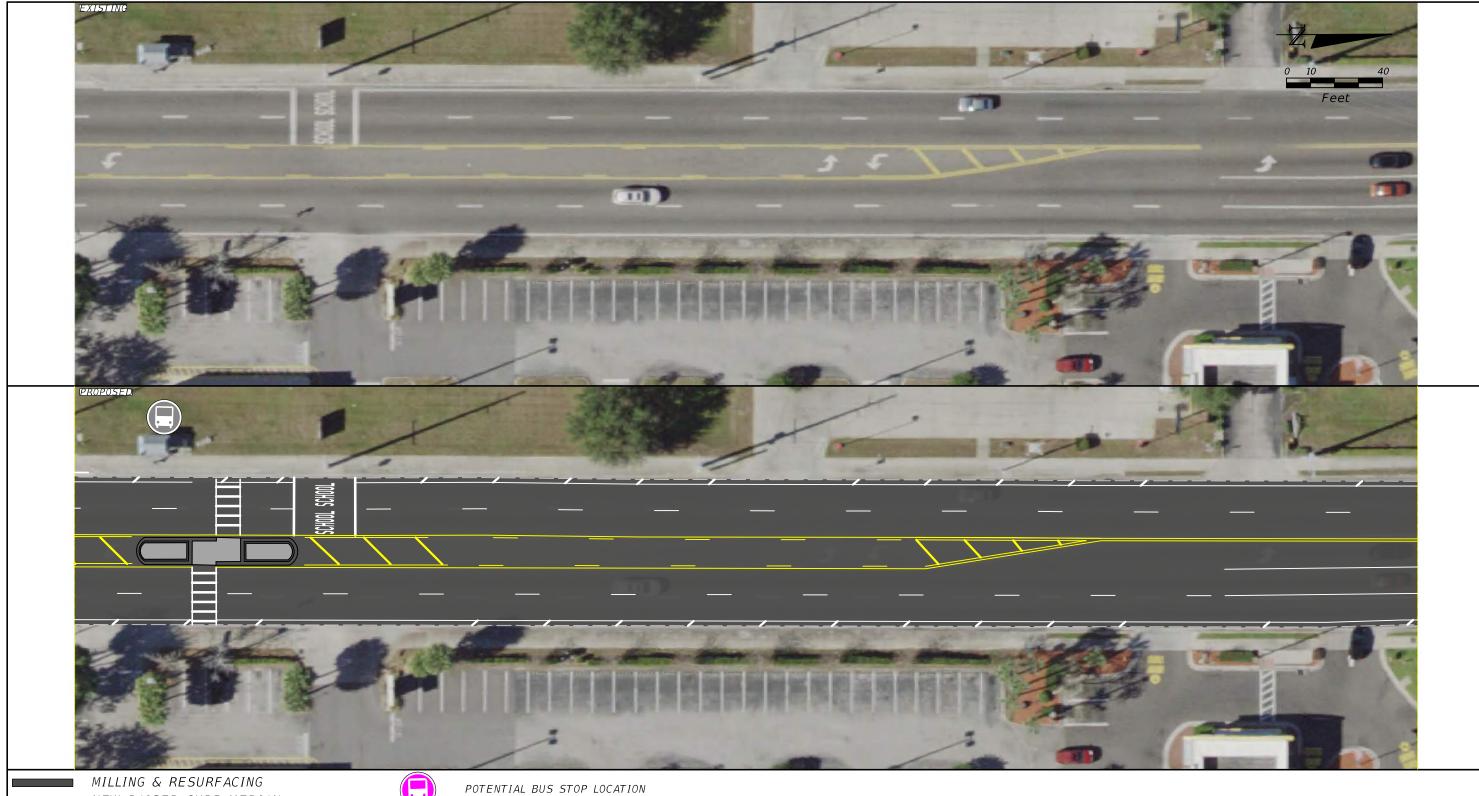
EXISTING BUS STOP LOCATION TO BE RELOCATED

EXISTING BUS STOP LOCATION

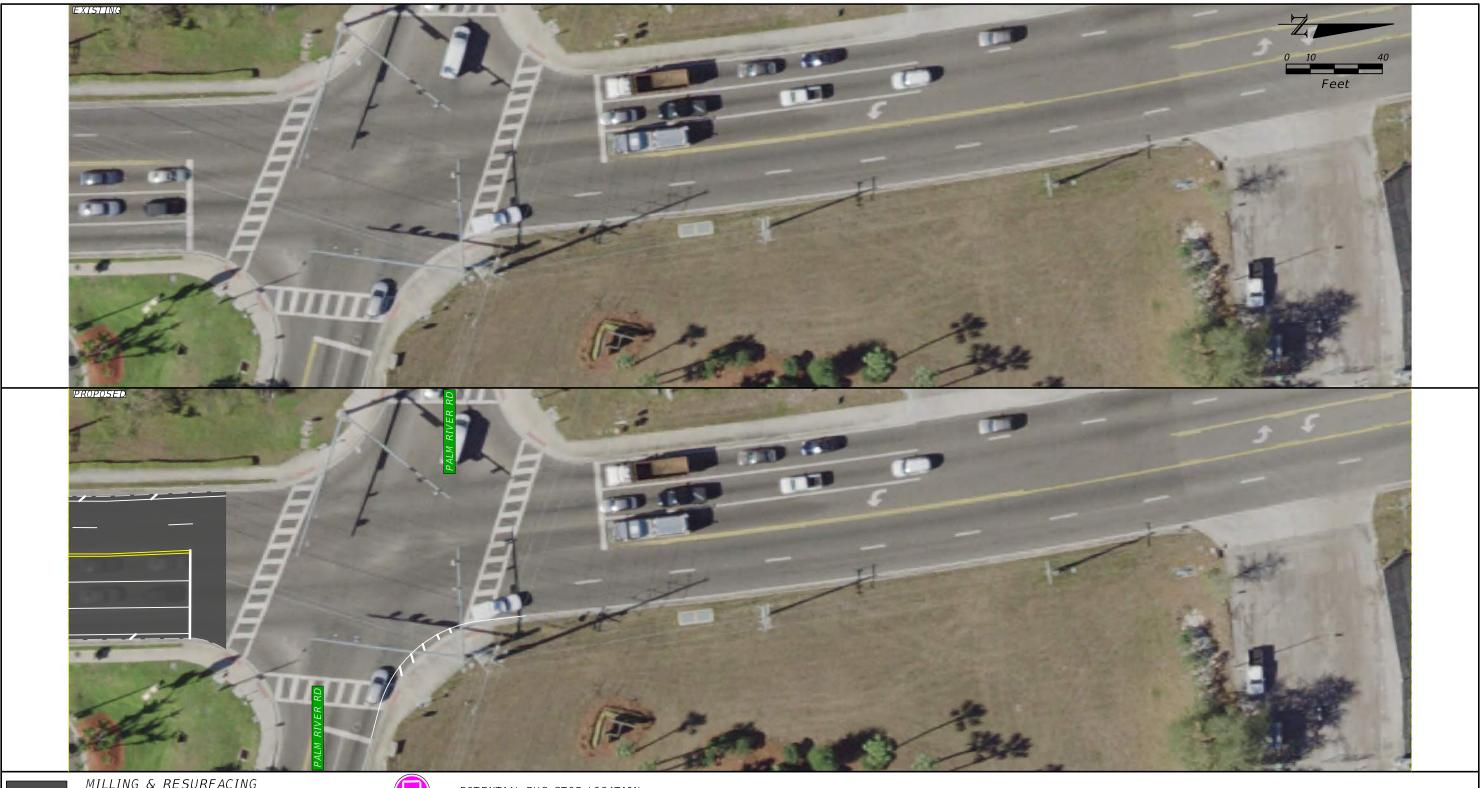
MILLING & RESURFACING NEW RAISED CURB MEDIAN NEW SIDEWALK NEW RAISED CURB LANDSCAPE MEDIAN
